## THE MAJOR CAUSE OF BUILDING FAILURE IN THE REGION AFFECTED BY THE TURKEY-SYRIA EARTHQUAKE

Tse-Shan Hsu

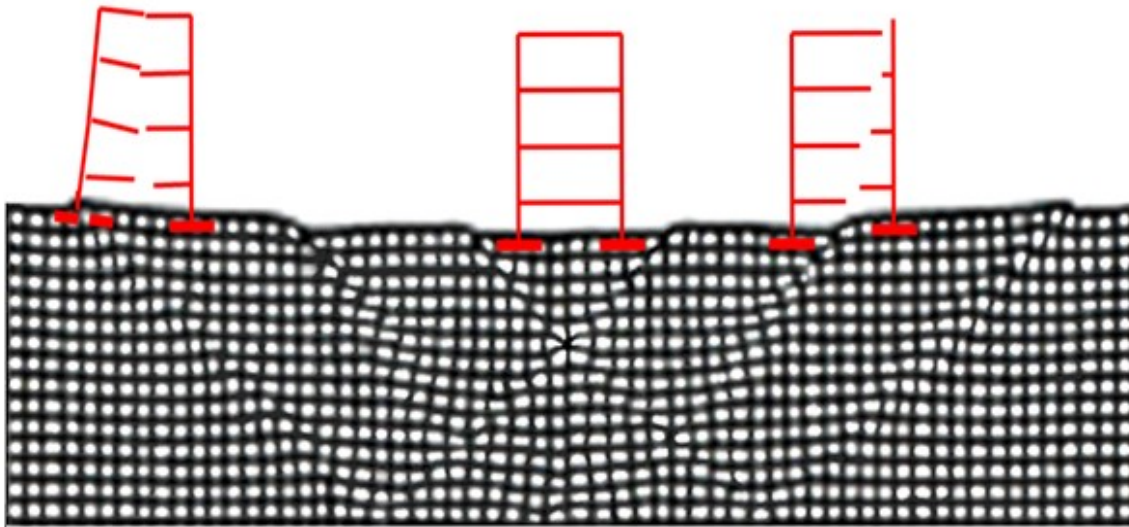
(a) Schematic diagram (Hsu, 1987; Hsu, et al., 2017).

seismic conditions specified in the original design of fortification against ground vibrations recommended in the seismic design code for buildings. Therefore, the buildings can maintain stability during tectonic earthquakes, as depicted in the center of Figure 4(a) and right of Figure 4(b).

buildings fail when seismic conditions change to non-seismic conditions (as for the failed buildings shown on the left and right sides of Figure 4(a) and in Figure 4(b)).

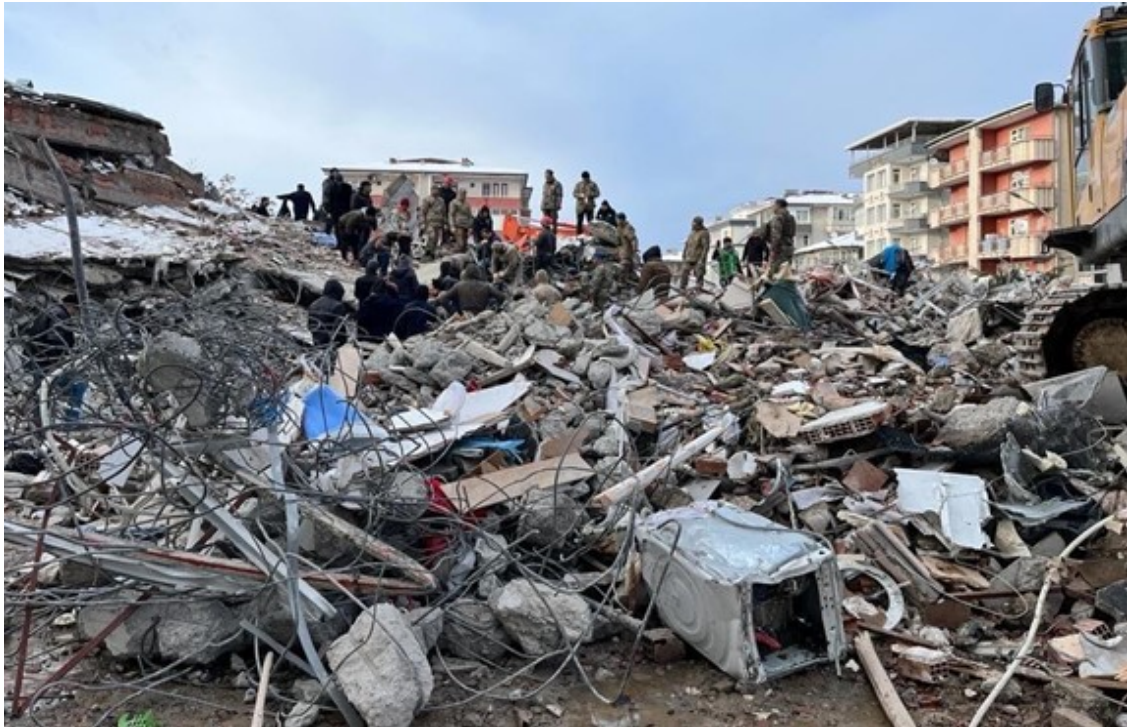
(b) Photograph of a disaster area in Turkey (CDP, 2023).

Figure 4. Comparison of building stability in a non-shear banding zone and building failure in a shear banding zone during a tectonic earthquake.

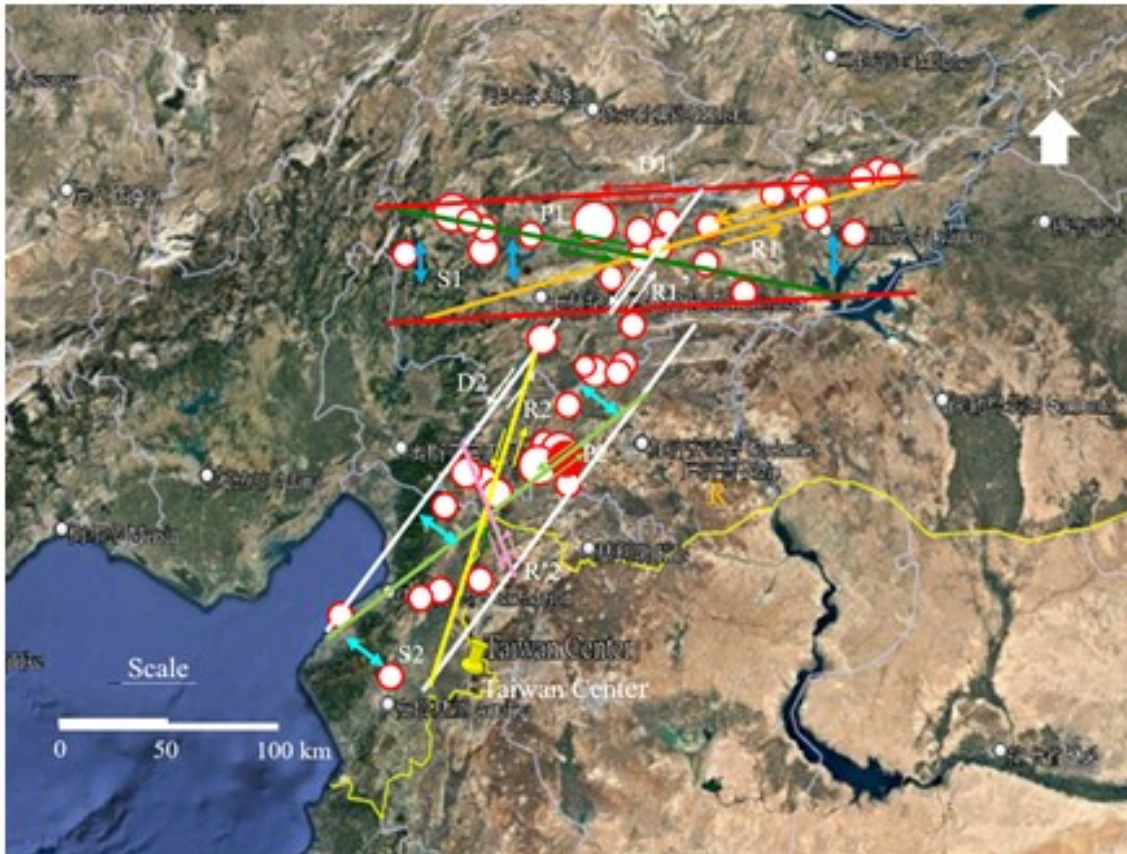
(b) After the overlaying of the shear band and shear structures

was only 17.9 km. Therefore, the method proposed by Hsu and Kang (2010) can be applied in conjunction with the epicentral distribution map of the mainshock and aftershocks of the Turkey-Syria earthquake (Figure 5(a)) to identify the shear textures within the entire width of the shear band in Turkey (depicted in Figure 5(b)) that occurred during the Turkey-Syria earthquake. These shear textures encompass

the principal displacement shears D1 and D2 of strikes  $N87^{\circ}E$  and  $N37^{\circ}E$ , the thrust shears P1 and P2 of strikes  $N79^{\circ}W$  and  $N53^{\circ}E$ , the Riedel shears R1 and R2 of strikes  $N74^{\circ}E$  and  $N18^{\circ}E$ , the conjugate Riedel shears R1' and R2' of strikes  $N37^{\circ}E$  and  $N24^{\circ}W$ , and compression textures S1 and S2 of strikes  $N3^{\circ}W$  and  $N53^{\circ}W$ .

However, as illustrated in Figure 5, the Taiwan Center is situated outside the shear banding zone formed during the Turkey-Syria earthquake. In other

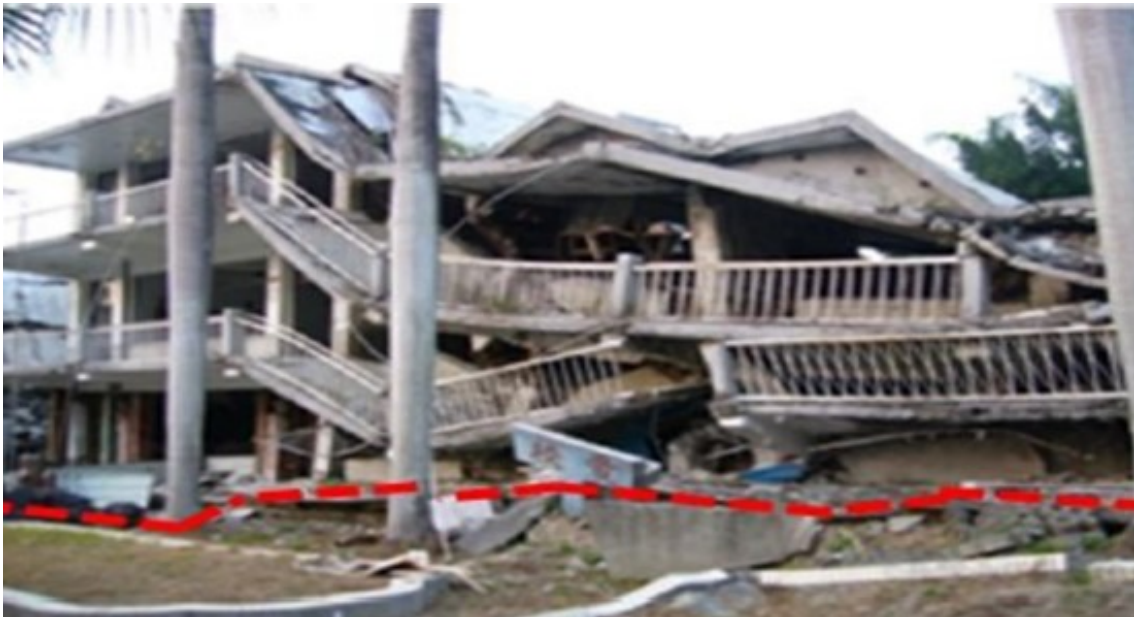
Figure 7. Collapse of Guangfu Junior High School in Taichung, Taiwan during the 921 Jiji earthquake in 1999 (Hsu, 2022).

Figure 7 shows the Guangfu Junior High School in Taichung, Taiwan that collapsed in the 921 Jiji earthquake in 1999. Figure 8(a) illustrates two stages of shear banding, involving tilting and uplift slopes before construc-

tion. As illustrated in Figure 8(b), the site was leveled by cutting and filling during the construction process, but two shear bands persisted below the site after leveling. As shown in Figure 8(c), the school building was constructed on the leveled surface. The school building collapsed because of shear banding during the 921 Jiji earthquake, as shown in Figures 7 and 8(d).

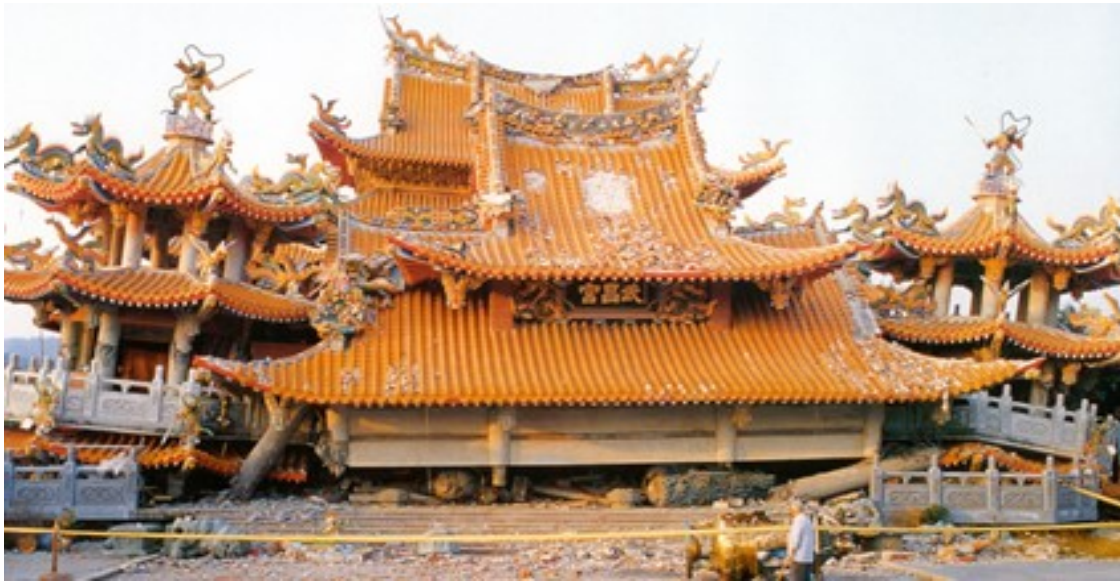
(a) Jiji earthquake in 1999 (Nantou, Taiwan; Hsu et al., 2018)

When the seismic settlement of the foundation ceases, the columns of the building endure the impact force transmitted from the foundation. This impact force is equivalent to twice the sum of all dead loads and live loads. Consequently, the piles of the building are severely fractured and damaged because of excessive loading, resulting in fall failure, as shown in Figure 9.

Figure 9. Cases of fall failures in previous earthquakes.

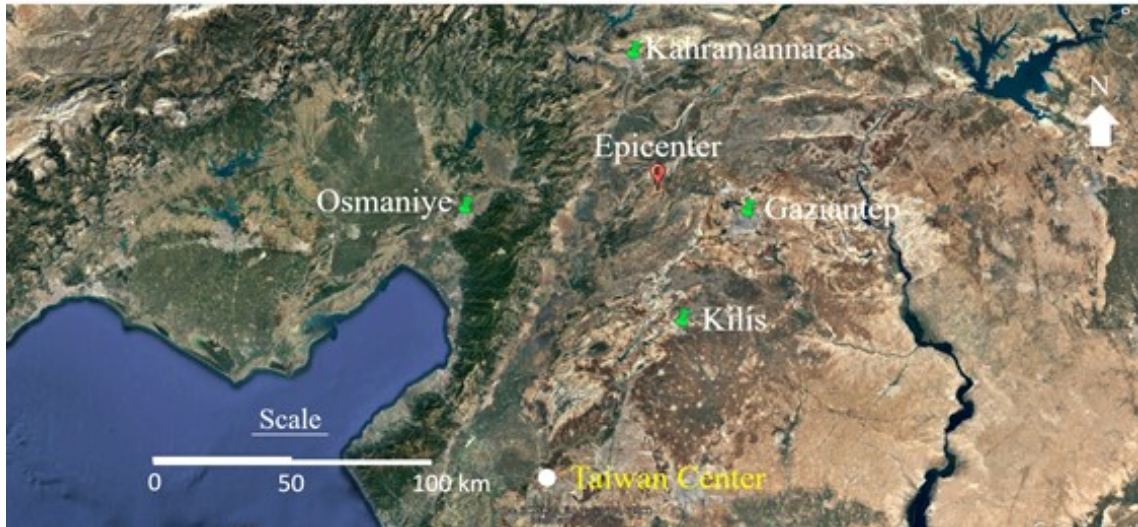
Figure 10. Epicenter of the Turkey-Syria earthquake and notable building failures in four neighboring provinces (Google Earth, 2019).

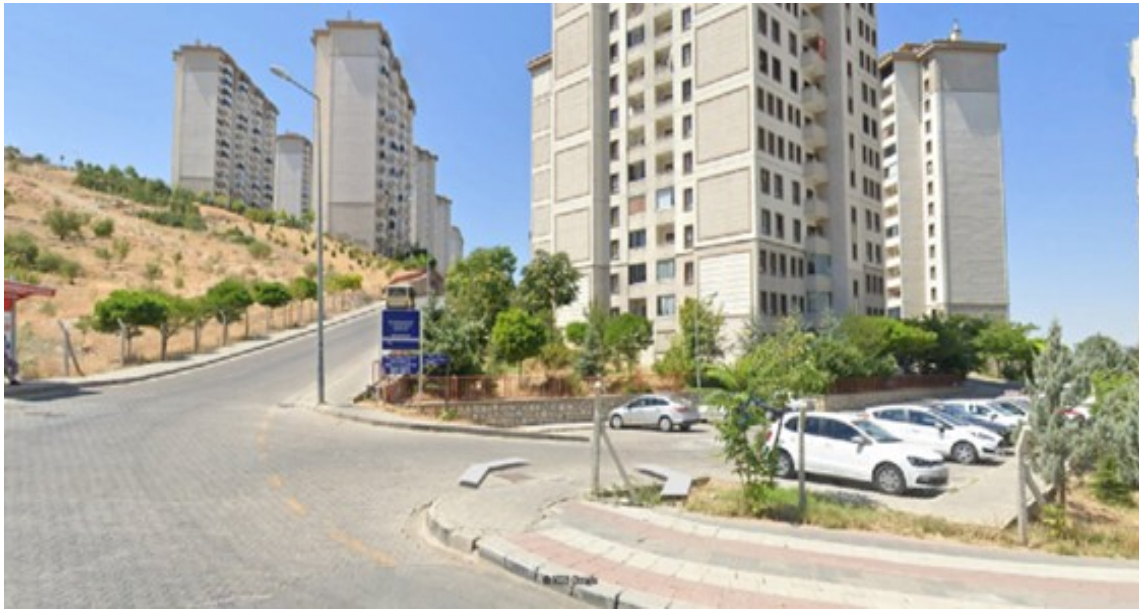
Figure 12. Buildings located on the shear banded, tilted, and uplifted slopes in Turkey (Google Earth, 2019).
