## MAJOR CAUSE OF FALL FAILURE OF MARKET BUILDINGS DURING TECTONIC EARTHQUAKES

Tse-Shan Hsu

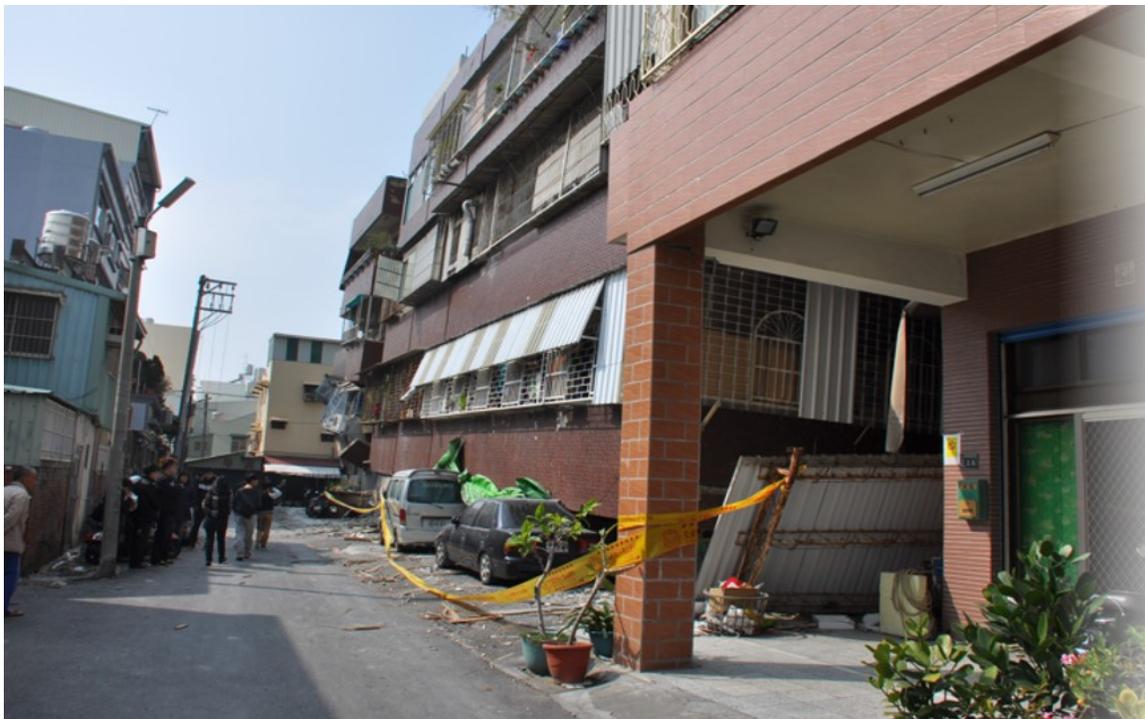
(a) Fall failure of the first floor

foundation, and the foundation impacts the soil layer at the moment earthquake subsidence suddenly stops, exerting excessive impact force on the columns on the first floor. As a result, the columns on the first floor are severely fractured under the influence of the excessive impact force (Figure 6).

Figure 6. Strain softening of shear band soil during a severe tectonic earthquake induces fall failure of a typical market building (Dazhi Market building, Tainan, Taiwan).

the market building will collapse. Therefore, it is known that during tectonic earthquake, the strain softening effect of alluvial sandy silt layer is the major cause for the fall failure of Dazhi Market building.

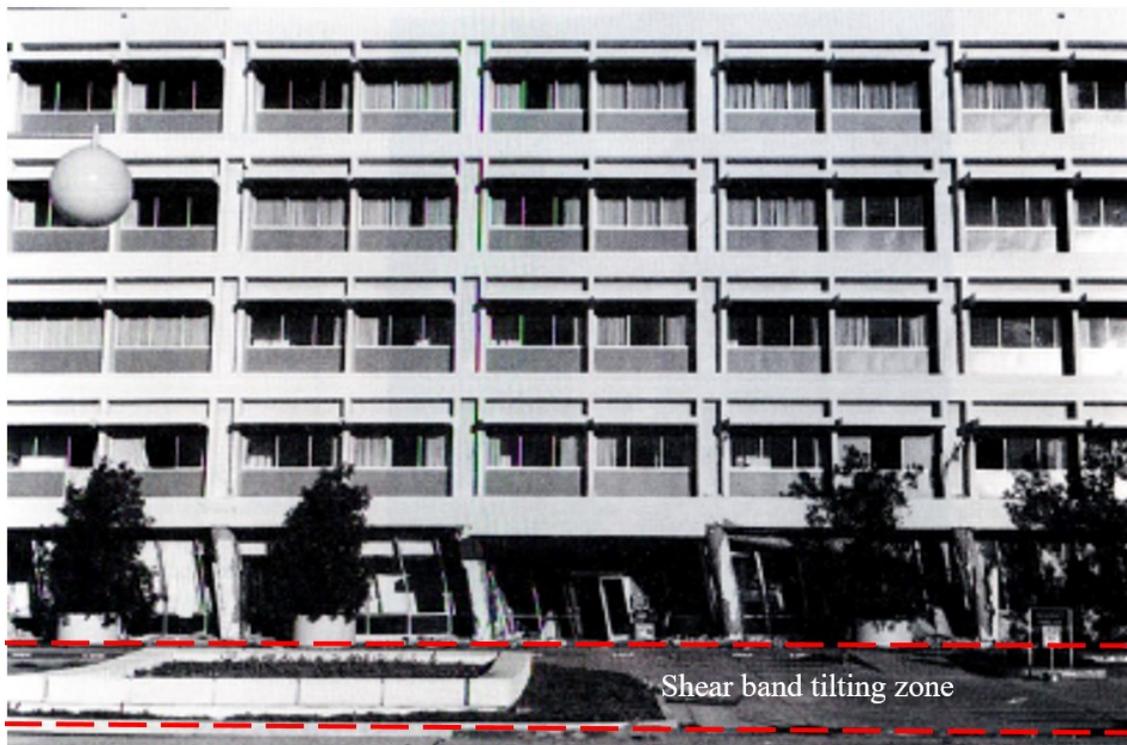
8) Figure 12 shows the failure of Olive View Hospital in the United States, accompanied by the shear-band tilt and uplift effect, resulting in an uneven uplift of the ground where the bottom ends of the columns on the first-floor are located. Therefore, when the horizontal ground surface could not maintain its level, the continuous stratum could not maintain continuity, and the rigid stratum could not maintain its rigidity, resulting in the breakage of columns on the first floor of the hospital. However, Figure 13 shows the

Figure 12. Shear banding induced failure of Olive View Hospital (Chopra, 2007).

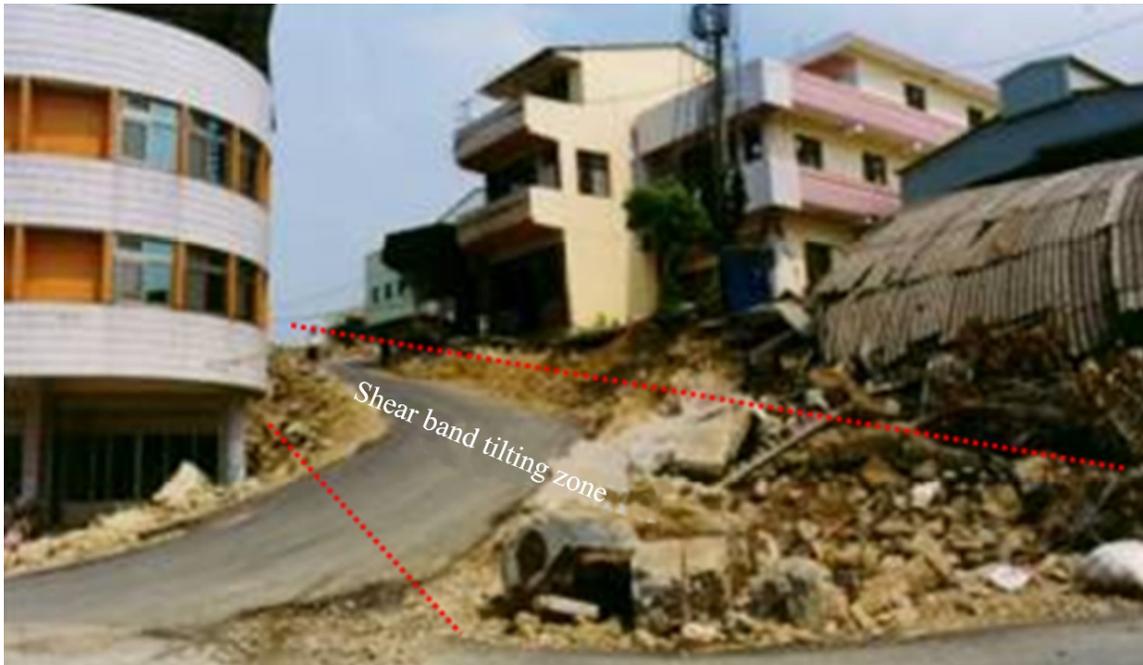
Figure 15. The buildings on both sides of the shear band that was tilted and uplifted in the 921 Jiji earthquake continued to remain stable.
