THE MAJOR CAUSE OF BUILDING FALL FAILURES DURING TECTONIC EARTHQUAKES

Tse-Shan Hsu
Department of Civil Engineering, Feng-Chia University
Taiwan R.O.C.
tshsu@fcu.edu.tw

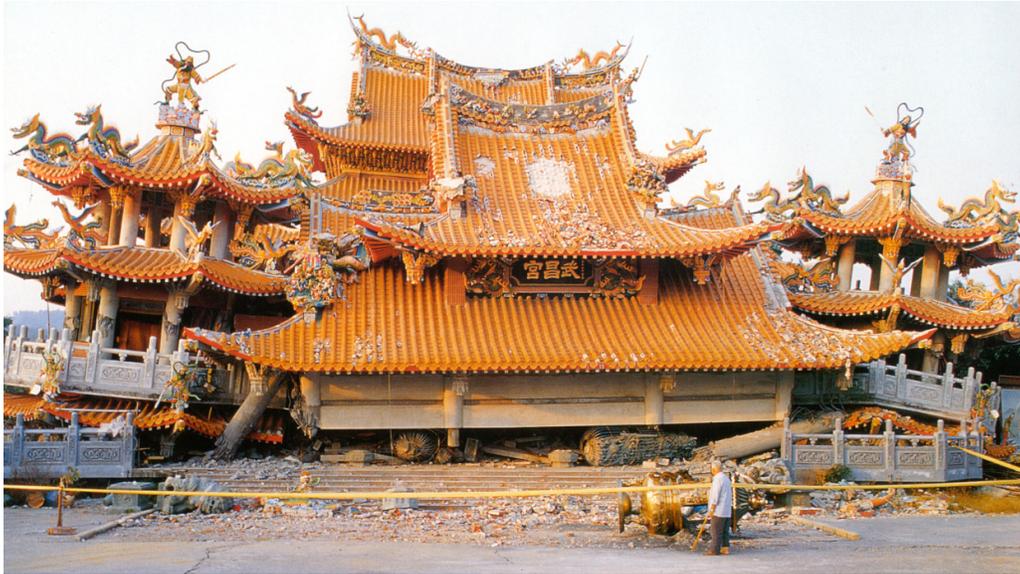
(a) Jiji Earthquake in 1999 (Nantou, Taiwan)

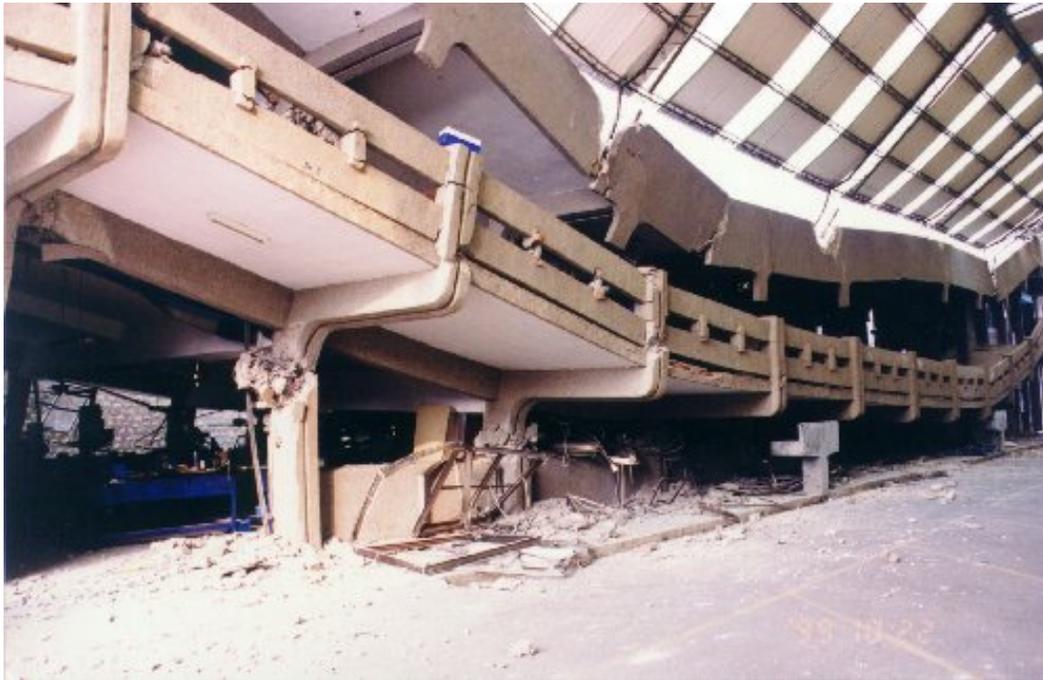
(b) Jiayi Earthquake in 1999 (Jiayi, Taiwan)

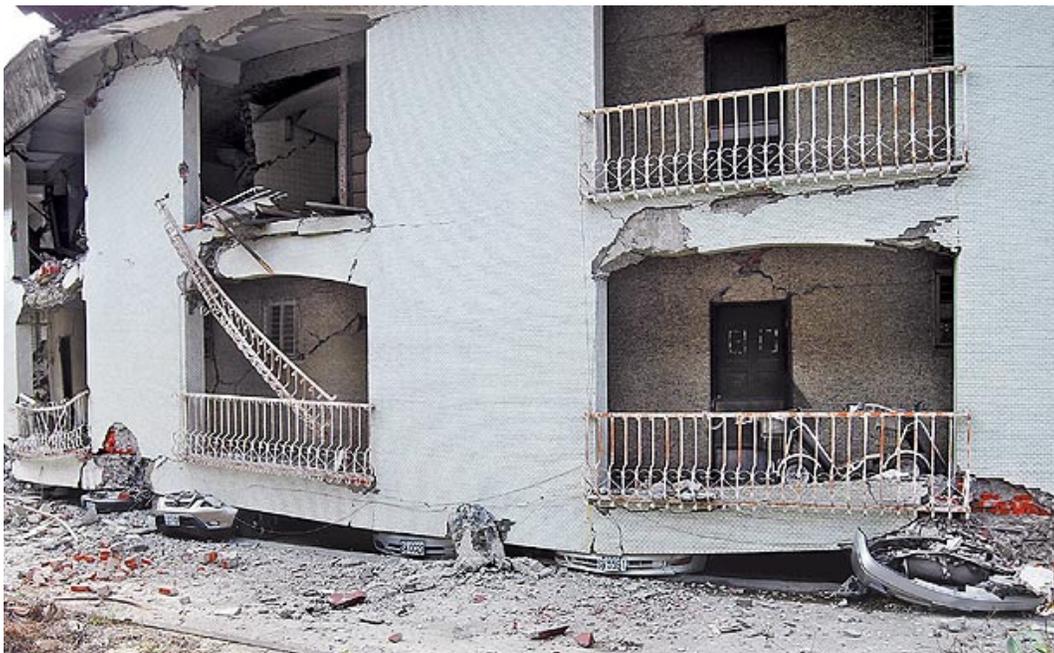
(c) Jiaxian Earthquake in 2010 (Tainan, Taiwan)

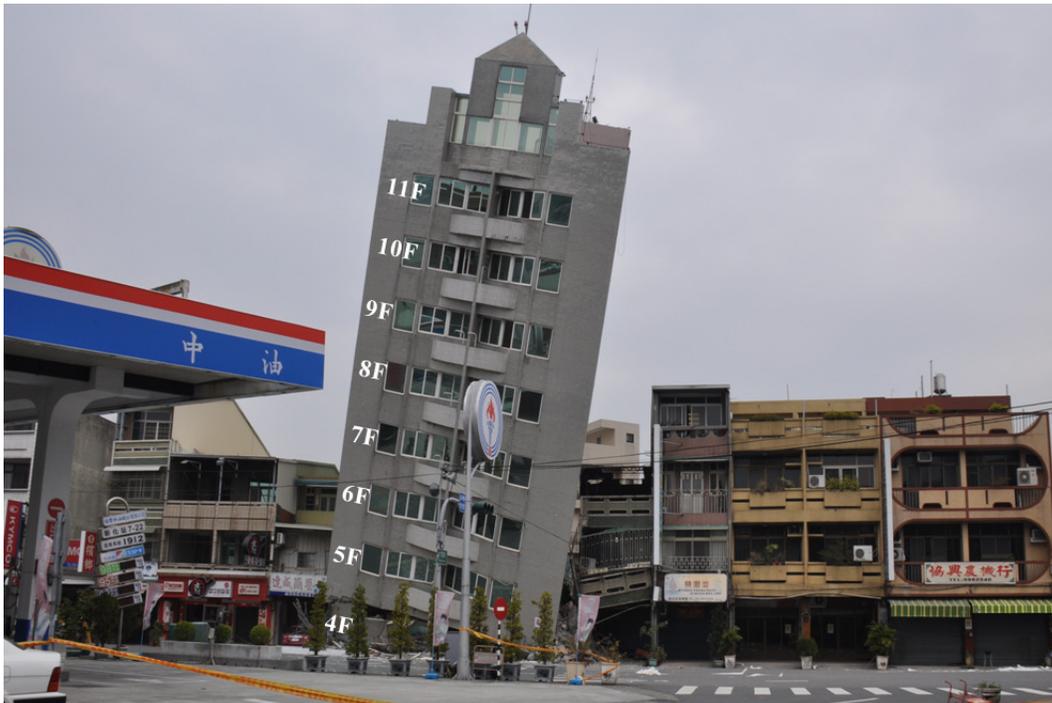
(d) Meinong Earthquake in 2016 (Tainan, Taiwan)

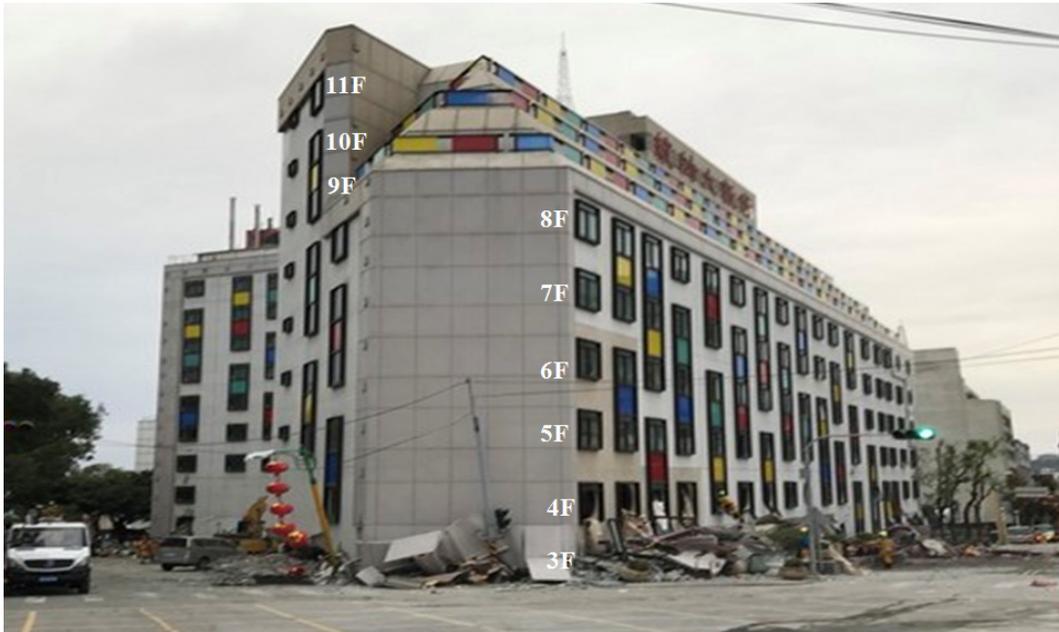
Figure 3. Fall failure of the 11-floor Tongshuai Building in the 0206 Hualien Earthquake in 2018 (Hualien City, Taiwan)

Figure 3 indicates that the Tongshuai Building suffered fall failure in the 0206 Hualien Earthquake in 2018. This paper will investigate the conditions and mechanism of building fall failures discussed above to discover the major cause of the fall failure of the Tongshuai Building.

Figure 14b indicates that the Tongshuai Building is located on the shear textures of a shear band related to the Milun Fault, and the 0206 Hualien Earthquake has been confirmed to be induced by Milun Faulting according to the geological investigation of the Department of the Economy; however, because the magnitude of the earthquake was only 6.0, the cumulated amount of shear banding in the urban area of Hualien city is not so significant. Therefore, the Tongshuai Building fall failure was triggered by combined conditions. These conditions include: (1) $FE_s = 3.0$; (2) the GWT is above the bottom surface of the foundation; (3) the foundation soil contains shear textures of a shear band; (4) ϕ_r for foundation soils is 30° ; (5) k_h and k_v are 0.153 and 0.0765, respectively. Under such conditions, the calculated FS_E is less than 1.0, and when seismic settlement occurred and sud-

denly stopped, the whole building suffered an impact, all the columns from the bottom floor to several floors above (even all floors) were fractured due to overloading, which then induced a severe building fall failure.

In a tectonic earthquake with $M_L=6.0$, Figure 3 shows that the columns in three floors of the 11-floor building all broke down; when $M_L=7.3$, Figure 4 shows that the columns in nine floors of the 16-floor building all broke down; when $M_L=7.6$, Figure 5 shows that all columns in the 11-floor building broke down. This is probably because under such combined conditions, the seismic settlement increases with the magnitude of earthquake.

1. Increase FS_S ; since $FS_S=3.0$ regulated in conventional Design Specifications cannot guarantee $FS_E > 1.0$, when designing foundations, the required FS_S must be decided by the back calculation to insure that $FS_E \geq 1.2$.

2. Lower the GWT; according to the thumb rule, the foundation static bearing capacity can be doubled when the GWT is lowered from the ground surface to the lowest level of the shear failure surface caused by the ultimate load.

3. Foundation soil does not contain shear banding effect; the areas where shear band is present can be identified by the monitored diagram of GPS velocity vectors, by which the location of the foundation can be shifted away from the shear banding effect.

4. To insure $\phi_r \geq 32^\circ$ for the foundation soil; in the case where it is impossible to determine that the foundation soil does not contain shear banding effect, multiple methods can be applied to improve the foundation soil. For example, re-

place silt or fine sand with gravel or grit, use geosynthetics to reinforce silt sand, or use group piles to reinforce raft foundations, etc., by which $\phi_r \geq 32^\circ$ for foundation soil and then the calculated $FS_E > 1.0$ can be guaranteed.

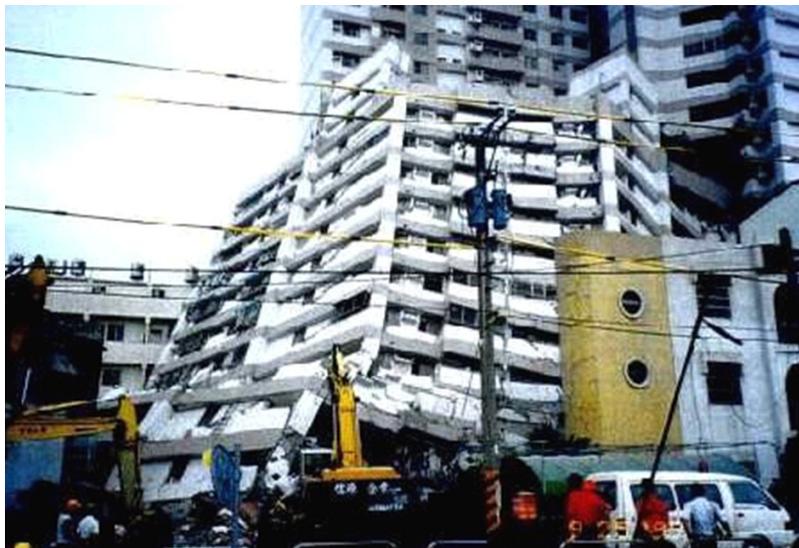
Figure 4. Fall failure of the 16-floor Longbang Wealth Celebrity Building in the 921 Jiji Earthquake in 1999 (Yuanlin Town, Changhua County, Taiwan)

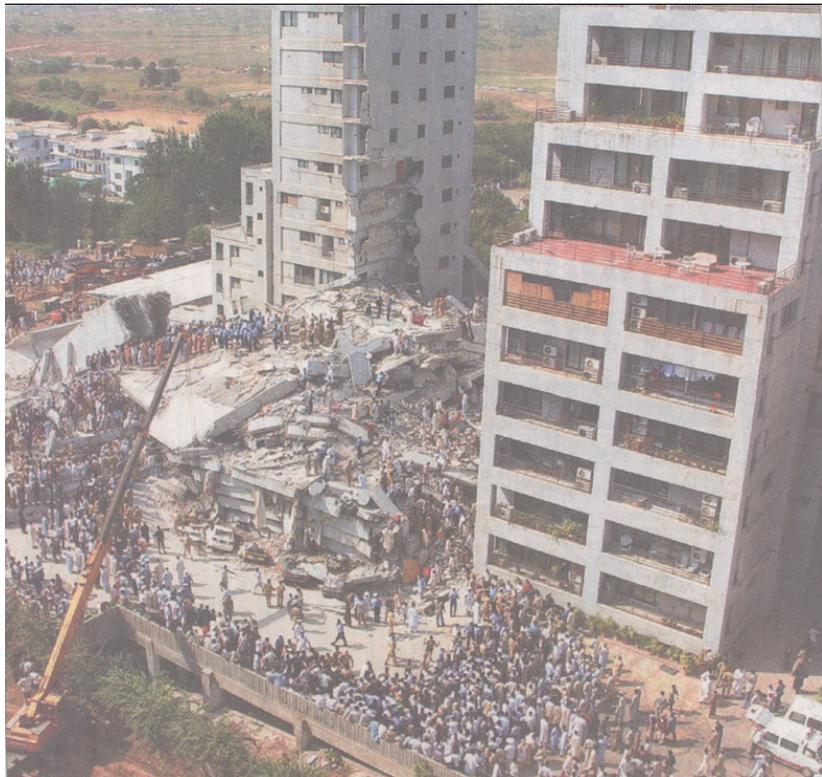
Figure 5. Fall failure of the 11-floor buildings in the 1008 Kashmir Earthquake in 2005 (George Pararas Carayannis, 2012)

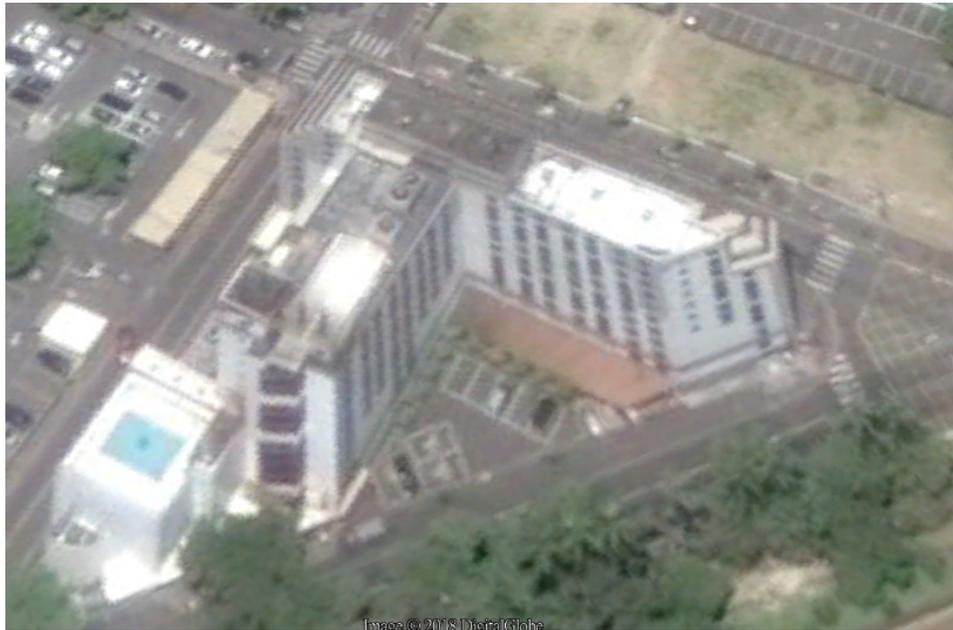
Figure 6 shows that before the earthquake, the foundation of the Tongshuai Building consists of two similar strip foundations that are orthogonal to each other. Where the strip foundation width B is 15m, foundation depth D_f is 4.5m.

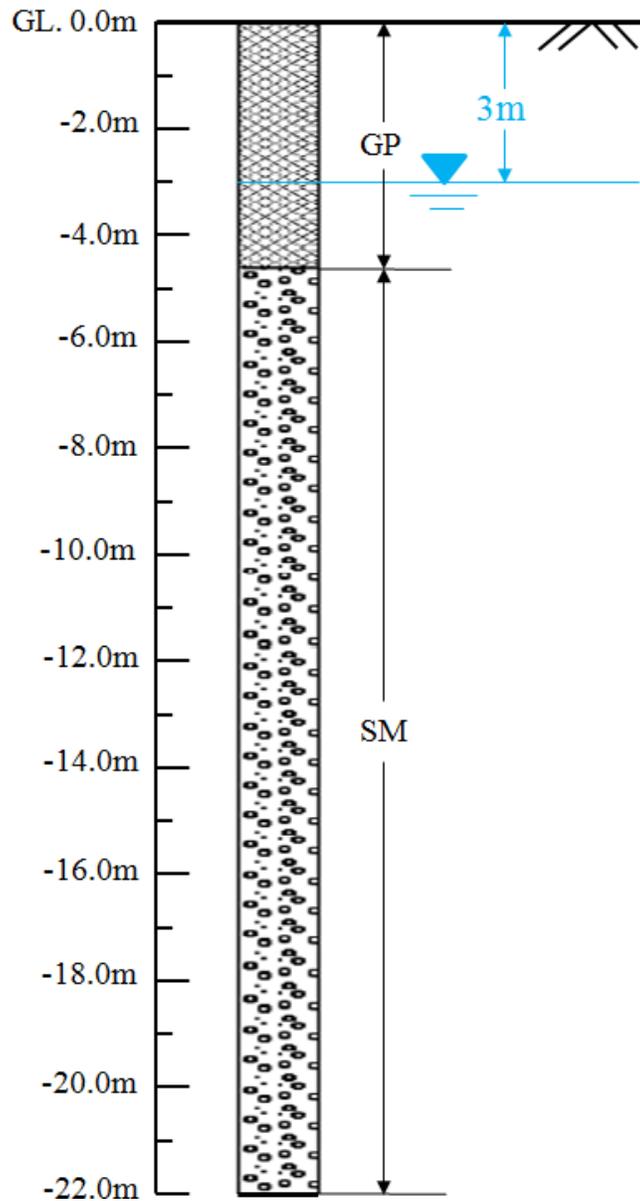
Figure 8 shows the boring log next to the foundation of the Tongshuai Building. According to Figure 8, the GWT in this area is 3m below the ground surface. Based on the unified soil classification system, the ground layer above the foundation floor is composed of poorly graded gravel

(GP); its average unit weight γ_{ave} is 22kN/m^3 . However, the ground layer below the bottom of foundation is silty sand (SM), with an average saturated unit weight γ_{sat} of 20.5kN/m^3 , an average ϕ_p of 32° , and an average ϕ_r of 30° .

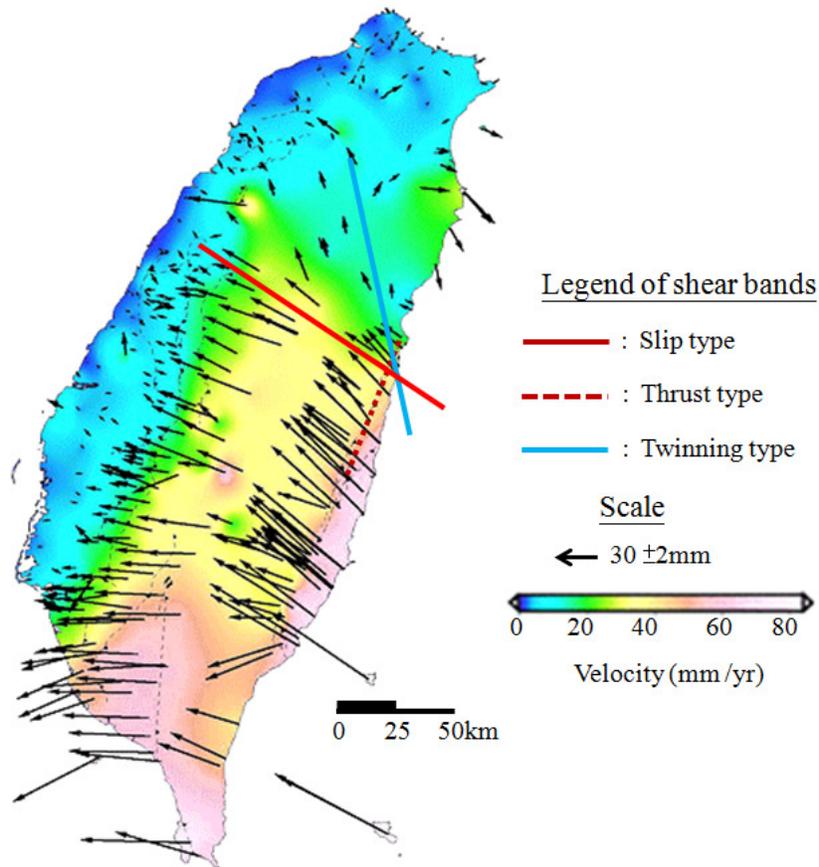
In addition, according to the GPS velocity vector diagram shown in Figure 13, there exists shear bands of slip type, twinning type, and thrust type in

the area near the Tongshuai Building, their dips are N56°W, N12°W, and N21°E, respectively.

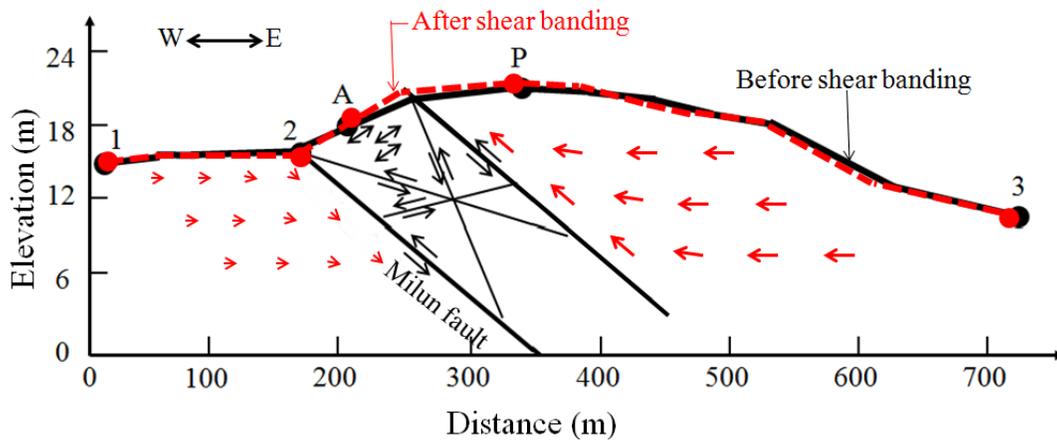
Since a shear band of thrust type can uplift hanging wall of the land, according to the shear band of thrust type shown in Figure 12 and Figure 13, it can be inferred that the Tongshuai

Building is located on a tilted slope, in which the eastern side is higher than the western side. This inference can be confirmed by the elevation profile shown in Figure 14b.

(b) Shear band going through the Tongshuai Building

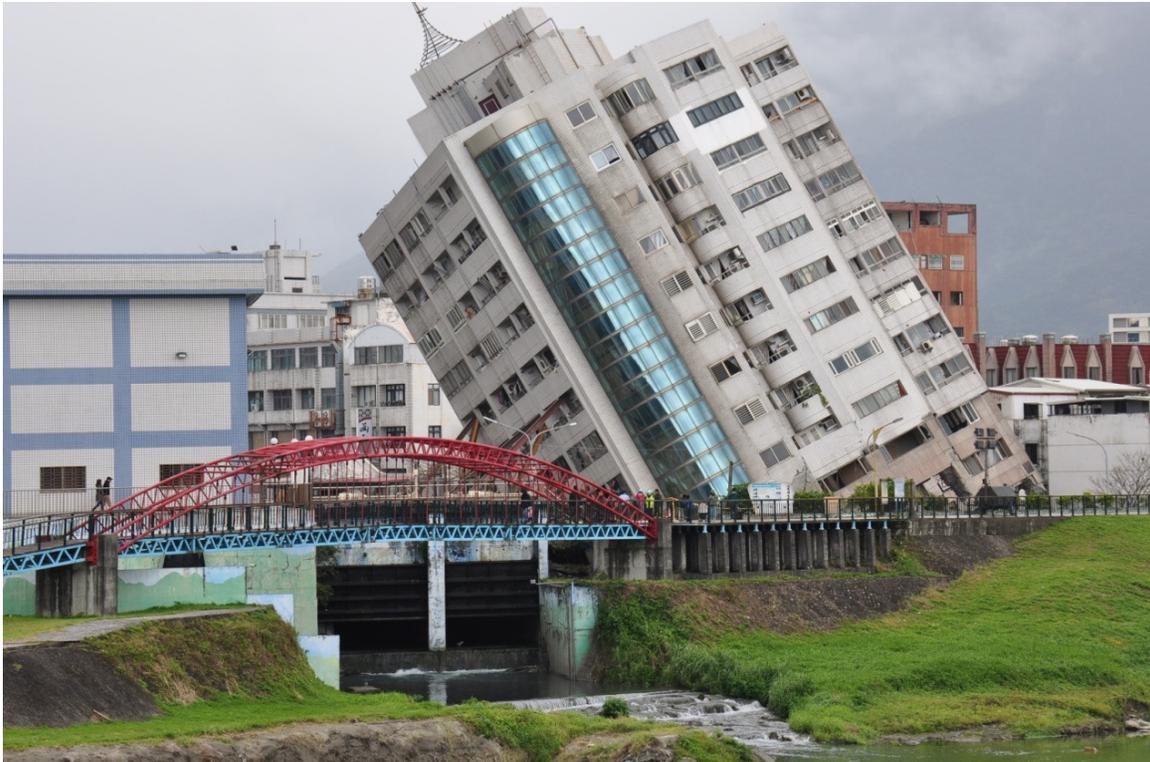
(a) Building leaning induced by local shear failure of foundation

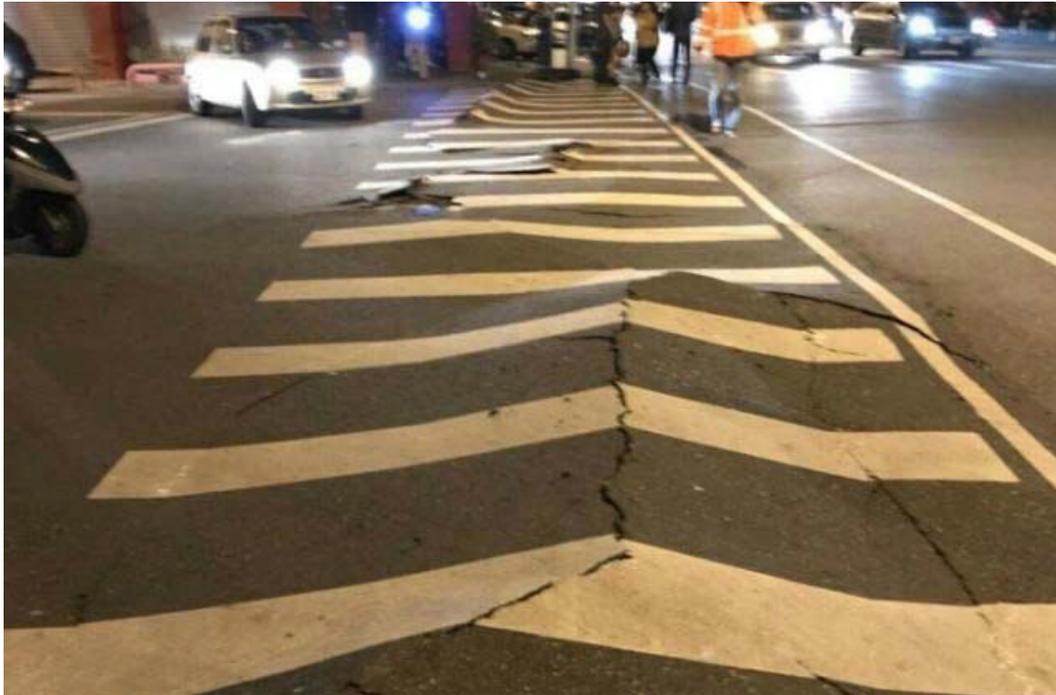
(b) Local uplifts of a road induced by local shear banding effects

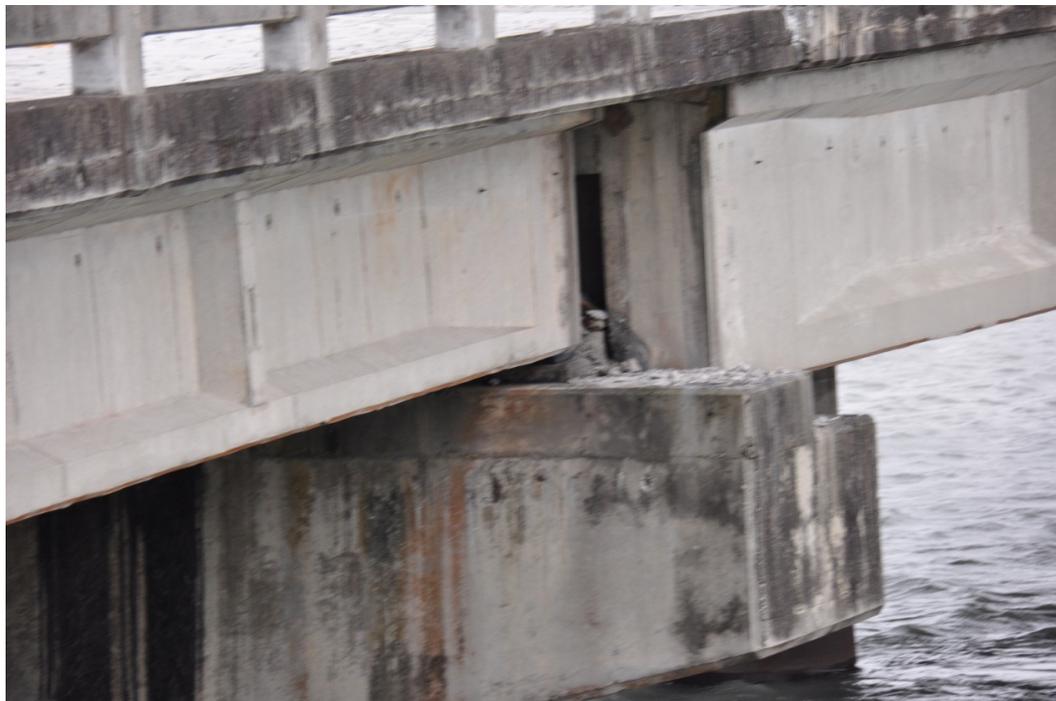
(c) Lateral movement of the bridge girders caused by shear banding

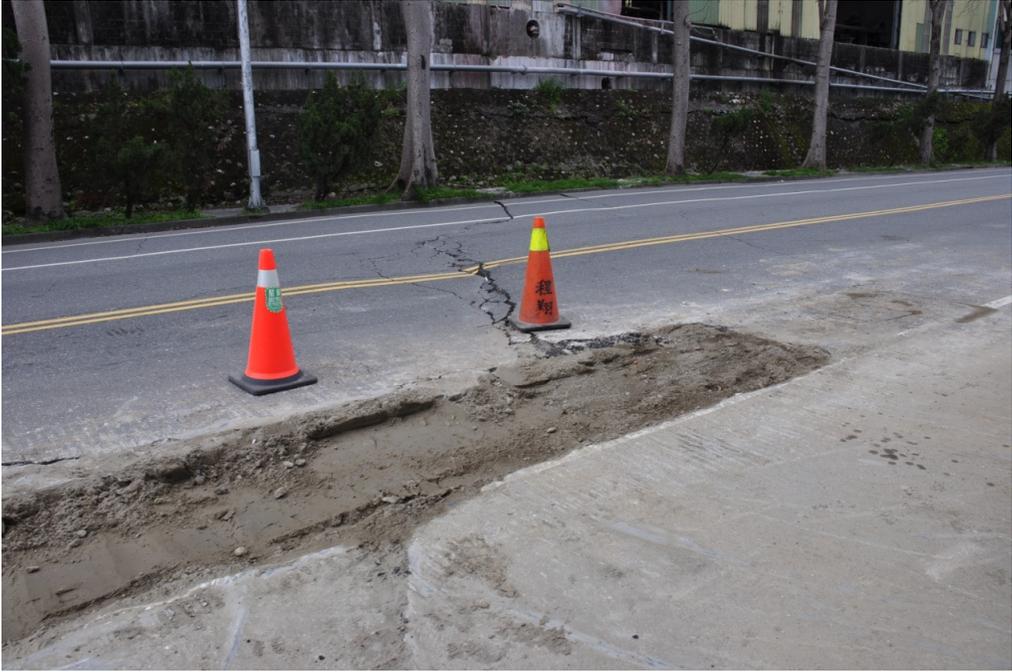
(d) A finished repaired broken tap water pipe below the hill road caused by local shear banding effect

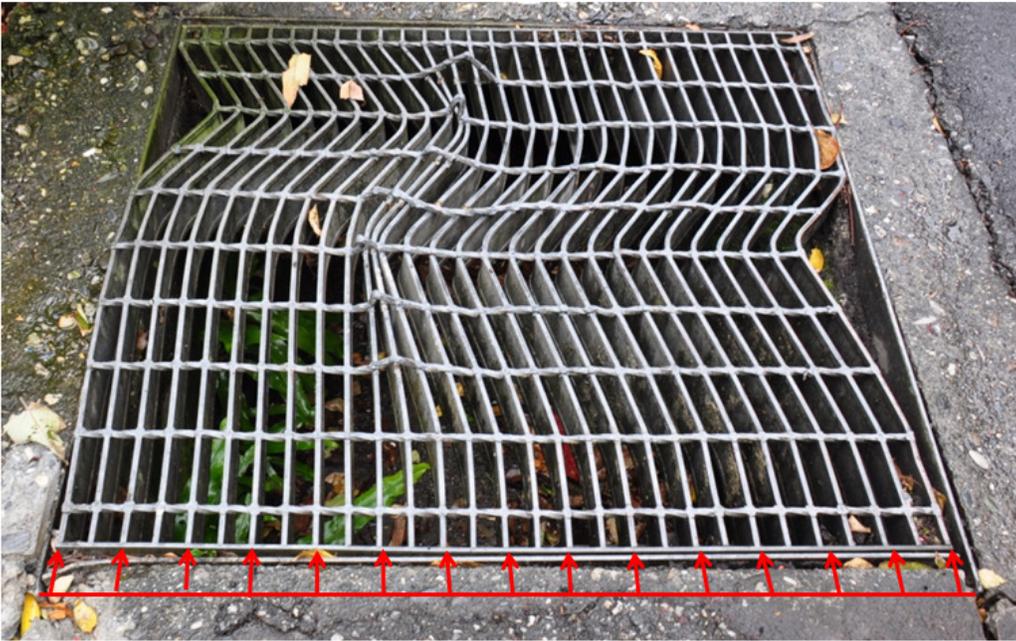
(e) Twisting of a gutter cover caused by lateral compression

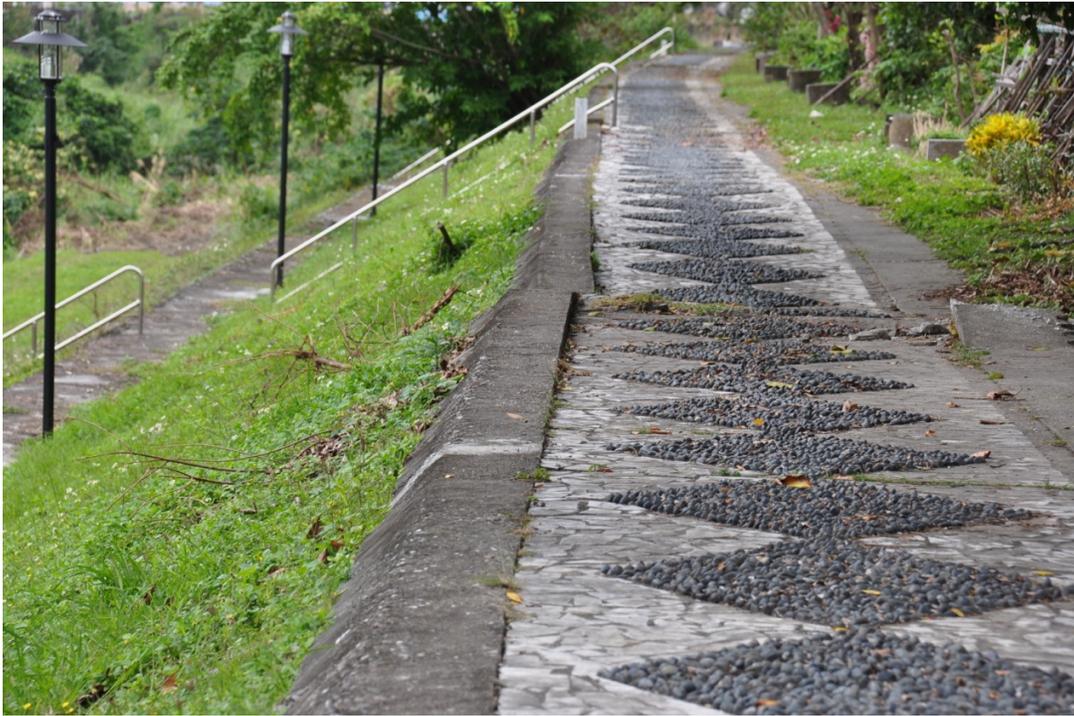
(f) Local ruptures on a embankment induced by localizations of deformations

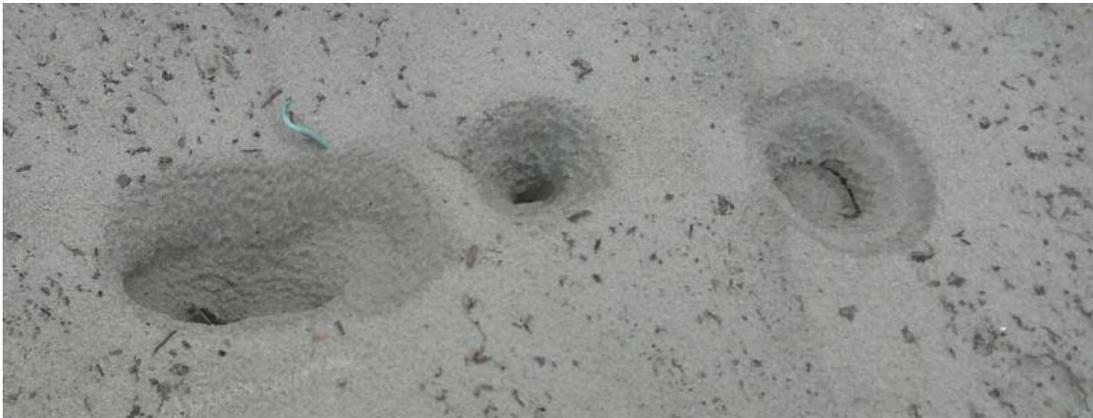
(g) Piped shaped soil liquefactions in the Meilun riverbed (Ke, 2018)

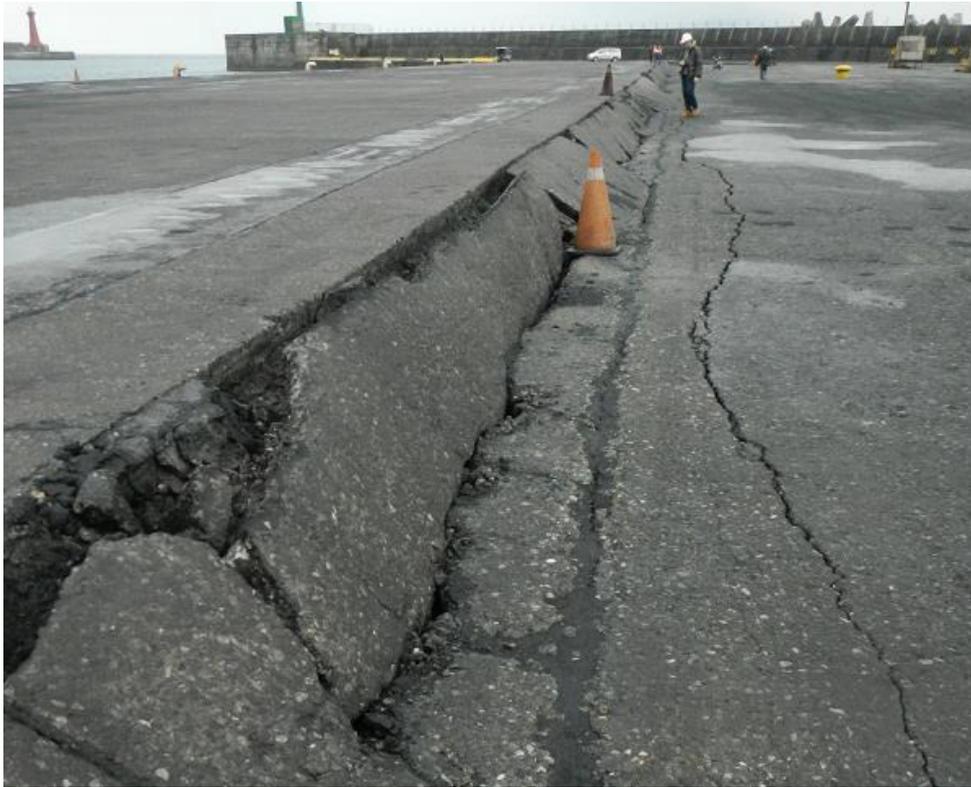
(h) Seismic settlement of a gravel-sand-filled pier (Ke, 2018)
