CAUSES AND TYPES OF BUILDING FAILURE DUE TO TECTONIC EARTHQUAKES

Abstract

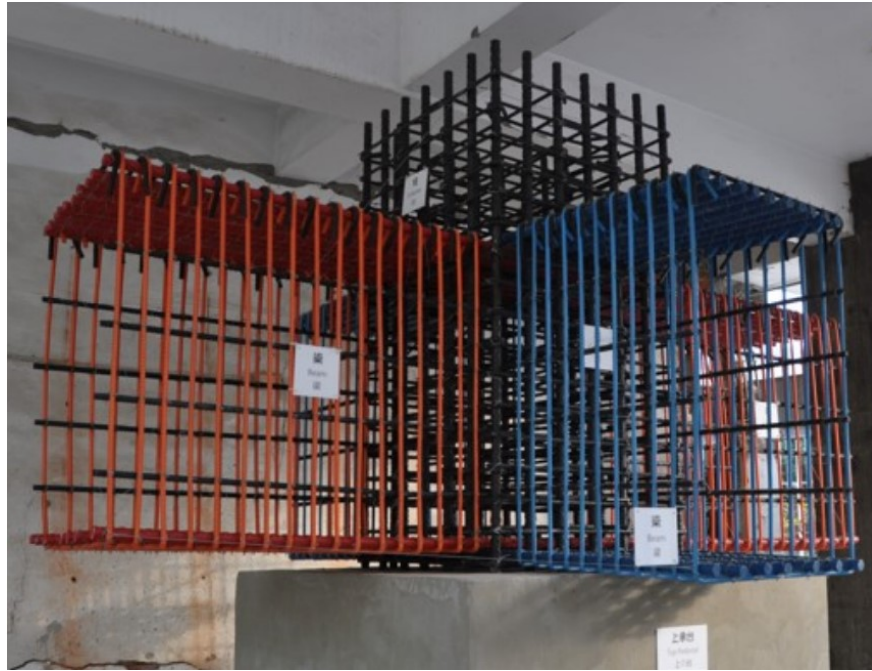
Figure 1. Increase in the cross-sectional area and number of reinforcement girders, columns, and girder-column joints due to the increase in ground vibration fortification levels (Hsu, et al., 2023).

As shown in Figure 1, the girders and columns of buildings designed according to the most recent seismic design codes have large cross-sectional areas and amounts of steel bars. How-

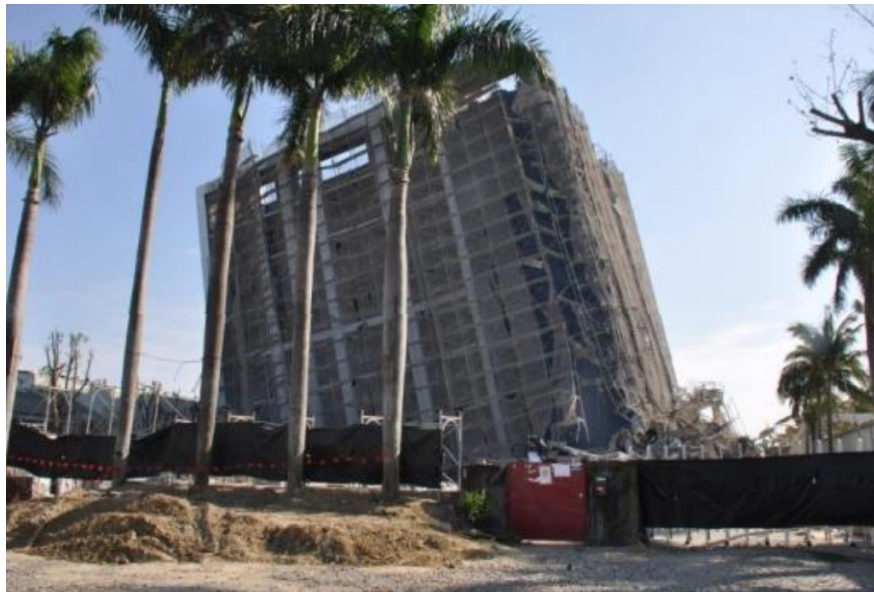
Figure 2. Failure in a building that complied with the latest seismic design code during the 2016 Meinong earthquake in Taiwan (Hsu, 2022a).

ever, despite the implementation of the latest code, building failures occurred during the 2016 Meinong earthquake, as illustrated in Figure 2. Thus, the following key aspects must be addressed before revising seismic design codes:

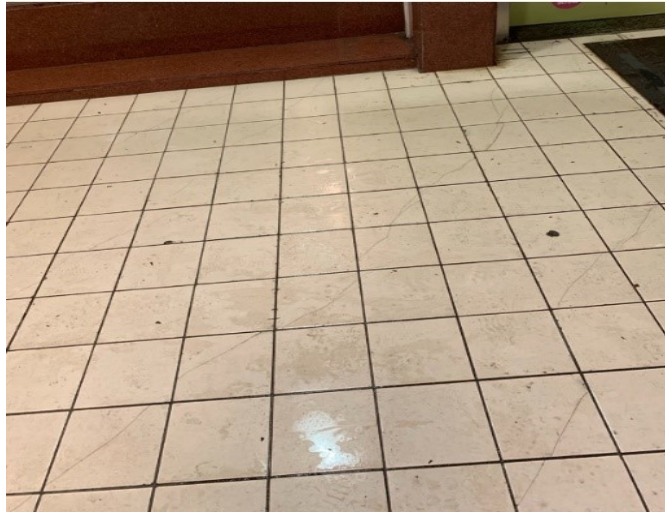
(a) Slab cracking when the seismic condition of a building changes slightly to a non-seismic condition (Hsu, 2022b)

Figure 3. Different types of building failure induced by different degrees of changes in seismic conditions.

Within the shear band zone, Hsu (2022b) addressed that even slight changes in the seismic conditions of the building to non-seismic conditions can result in slab cracking, as depicted in Figure 3(a). Moderate changes from seismic conditions to non-seismic conditions can cause the building to tilt and subside, as shown in Figure 3(b). Finally, significant changes from seismic conditions to non-seismic conditions can lead to the complete collapse of the building, as illustrated in Figure 3(c).

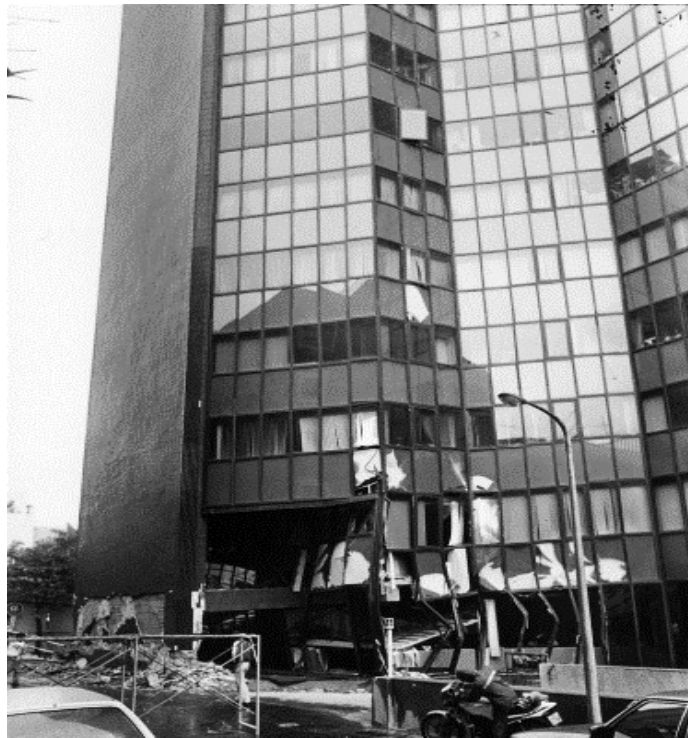
(b) Tilting and subsidence of a building when the seismic condition of the building changes moderately to a non-seismic condition (Hsu, 2019; Hsu, 2022b)

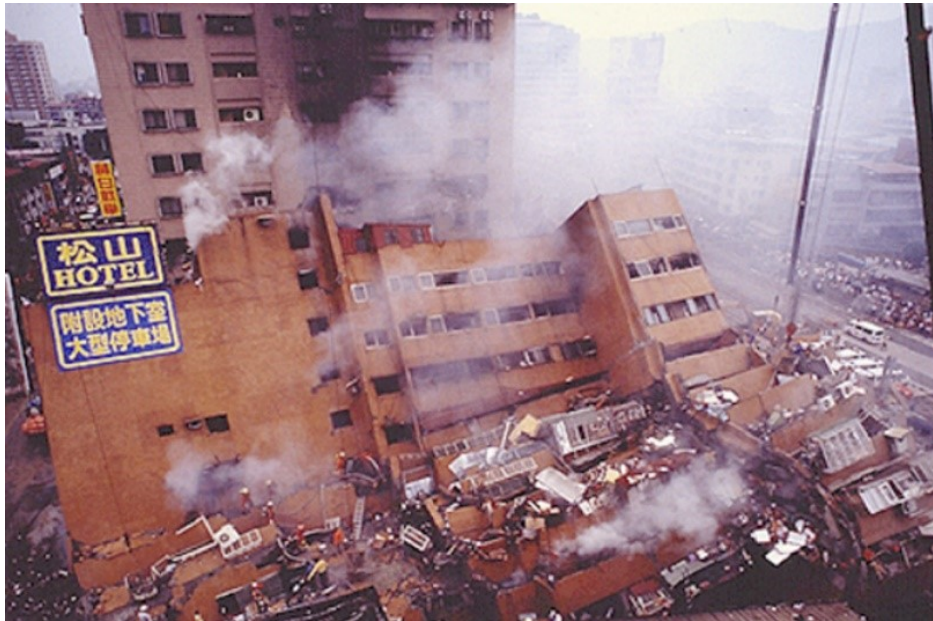
(c) Fall and collapse of a building when the seismic condition of a building changes highly to non-seismic (Zhao, 2020; Hsu, 2022b)

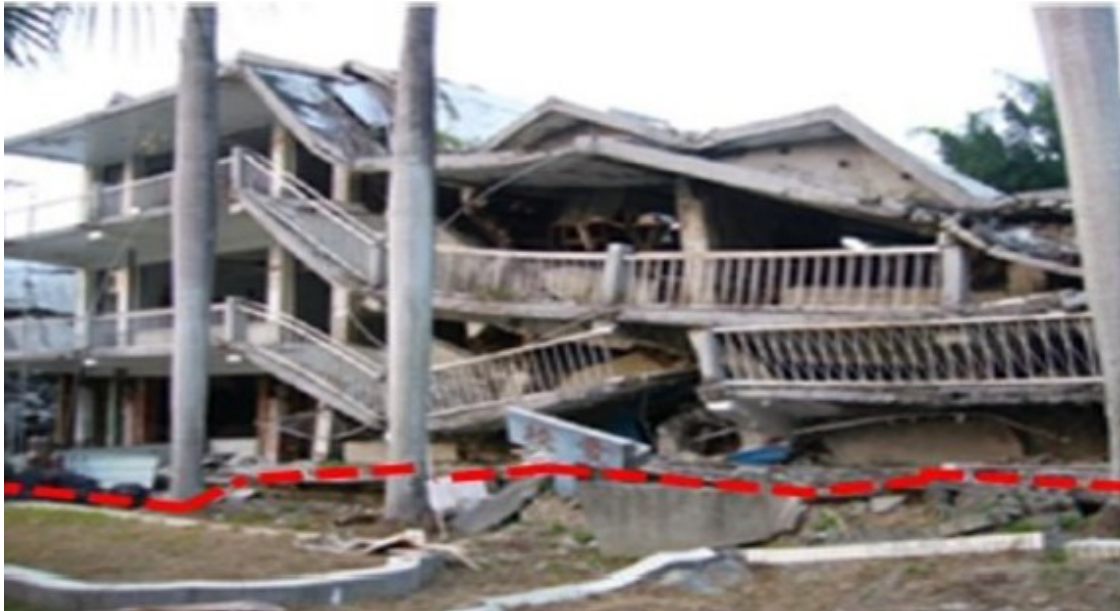
Figure 4 shows the collapse failure of the Guangfu Junior High School building in Nantou, Taiwan, during the 921 Jiji earthquake. The figure indicates that during the failure of the building, the original seismic conditions in the design changed to non-seismic conditions because of shear banding. Consequently, the ground where the bottom ends of all the col-

umns were situated experienced undulations caused by the uneven effects of plastic strain softening and tilting-uplift within the shear banding zone. Once all

the girders and columns were severely fractured, the building experienced collapse failure.

Figure 4. Collapse failure of the Guangfu Junior High School building in Nantou, Taiwan during the 921 Jiji earthquake (Hsu et al., 2023).

- 3) In the 921 Jiji earthquake, the collapse failure of Guangfu Junior High School occurred under non-seismic conditions, while the physical school building and the structural analysis model failed under seismic conditions. Thus, the collapse failure of Guangfu Junior High School differs significantly from the type of weak column-strong girder failure obtained from pushover tests and analyses. Therefore, the results of the pushover tests and analyses do not align with the actual requirements.

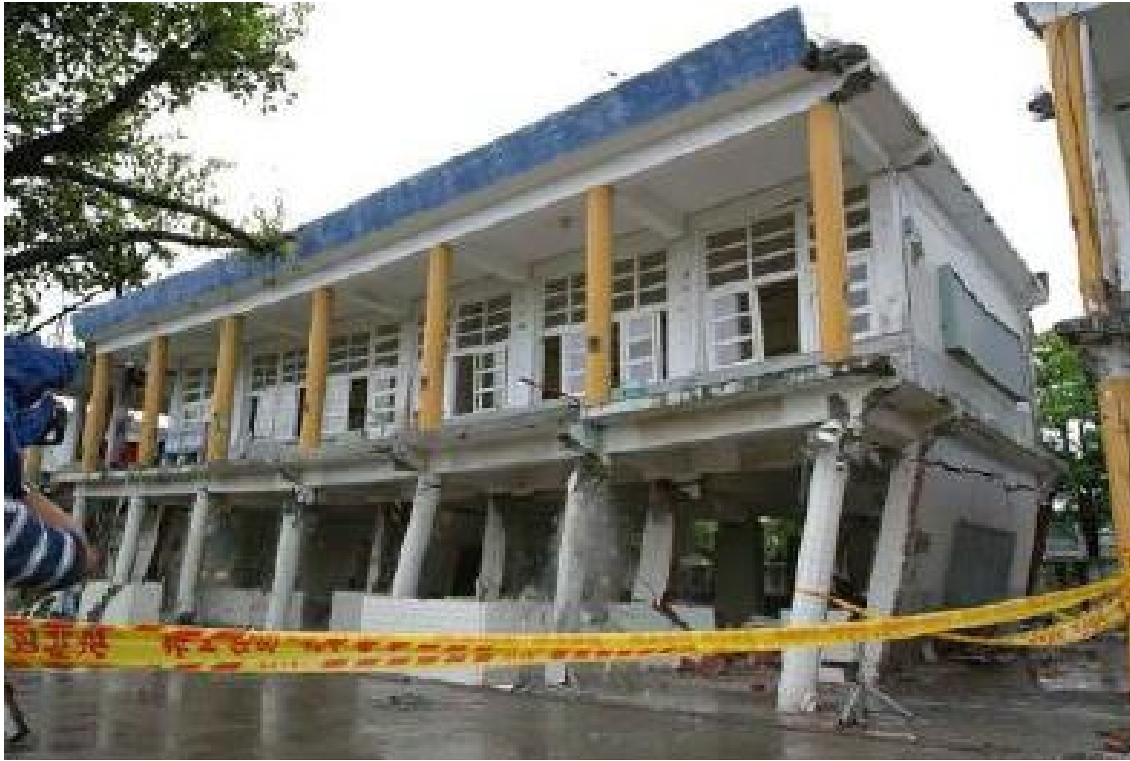
The seismic reinforcement method for school buildings, as provided by the NCREE, is based on pushover test results for school buildings (Hwang, 2009). Figure 5 demonstrates that the type of failure observed in a pushover test is weak column–

strong girder. Furthermore, Figure 5 shows that the original seismic conditions set in the design of a school building were consistently maintained during the pushover test. Because the school building did not experience failure under these seismic conditions, the weak column–strong girder type of failure in the pushover test was artificially imposed.

Figure 5. Imposed weak column-strong girder failure observed in the pushover test of a school building under seismic conditions (Hwang, 2009).

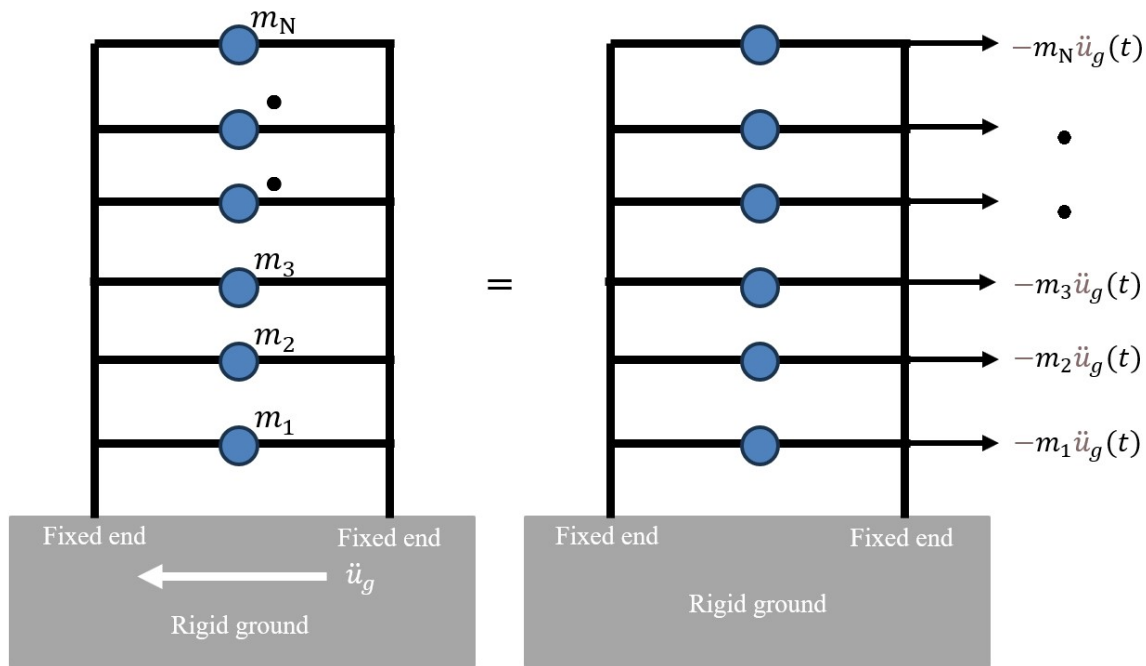
Figures 7–9 present the respective conditions necessary for using vibration isolation, vibration reduction, and vibration resistance technologies in the seismic design of buildings. To utilize these technologies, all the bottom ends of the building columns must initially be set as fixed ends in the original designs. Consequently, the ground on which the building columns rest must remain horizontal, continuous, and rigid during tectonic earthquakes. In other words, employing vibration isolation, vibration reduction, and vibration resistance technologies necessitates that the seismic conditions set forth in the original design are consistently maintained during tectonic earthquakes.

Figure 9. Conditions required for utilizing vibration resistance technology.

If a tectonic plate is divided into a shear banding zone and a non-shear banding zone, vibration isolation, vibration reduction, and vibration resistance technologies can only be applied in the non-shear banding zone, where the effects of only ground vibration are experienced, as illustrated in Figures 7–9.

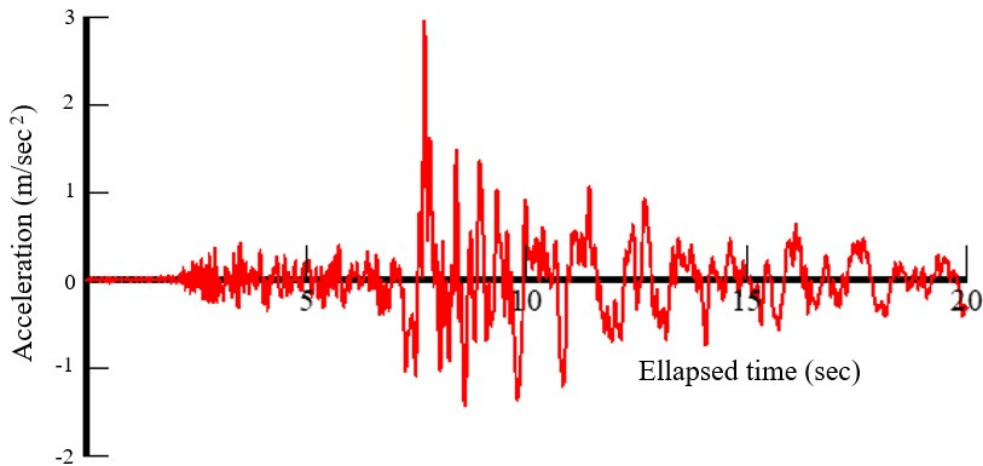
Figure 11. Ground acceleration time-history curve recorded using a seismometer (Hsu, 2018).
