## MAJOR CAUSE OF SUBSIDENCE OF ADJACENT BUILDINGS DURING FOUNDATION EXCAVATION

Tse-Shan Hsu

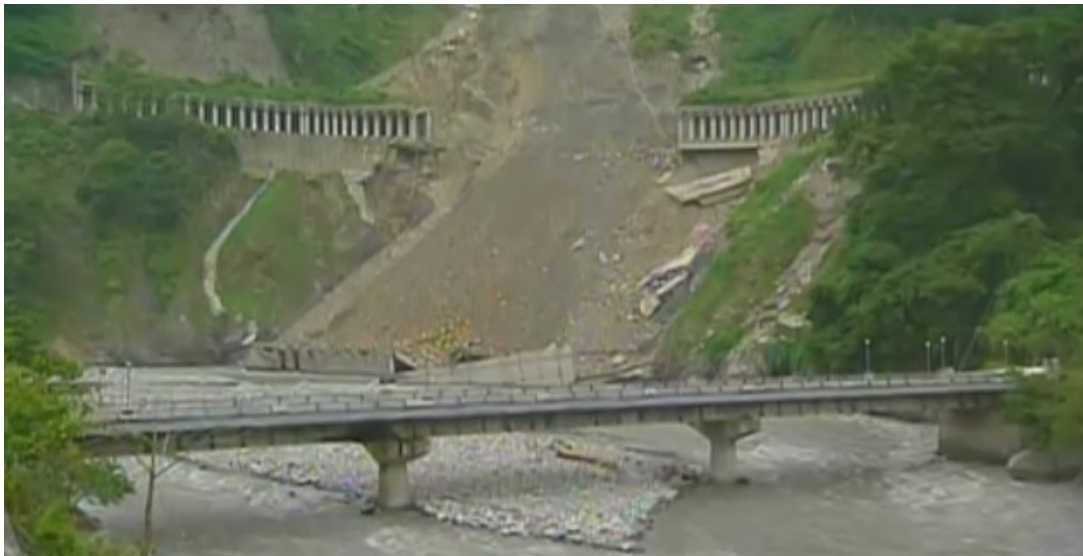
Figure 1. Piping failure of the retaining wall of the open-cut tunnel (Central Cross Highway in Taichung, Taiwan).

Figure 1 shows the piping failure of the retaining wall in the open-cut tunnel on the Central Cross Highway in Taichung. Figure 2 shows the piping failure of the gabion retaining wall along the bank of Toubiankeng Creek in Taichung. Figure 3 shows the piping failure of the retaining walls on both sides of the Gangweigou Creek floodway in Tainan.

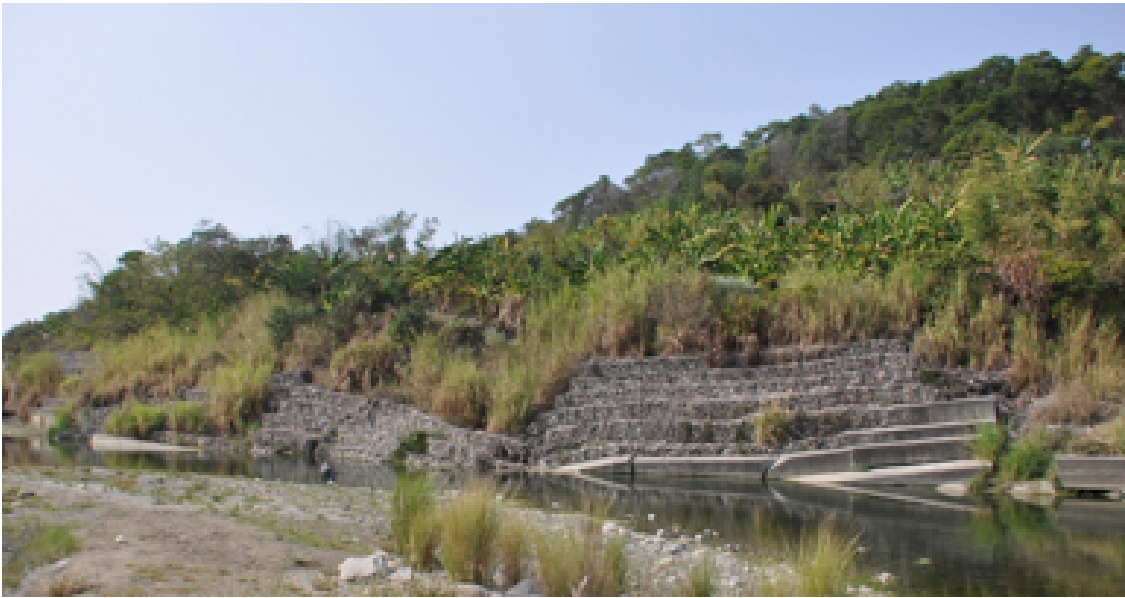
Figure 2. Piping failure of the gabion retaining wall (Toubiankeng Creek in Taichung, Taiwan).

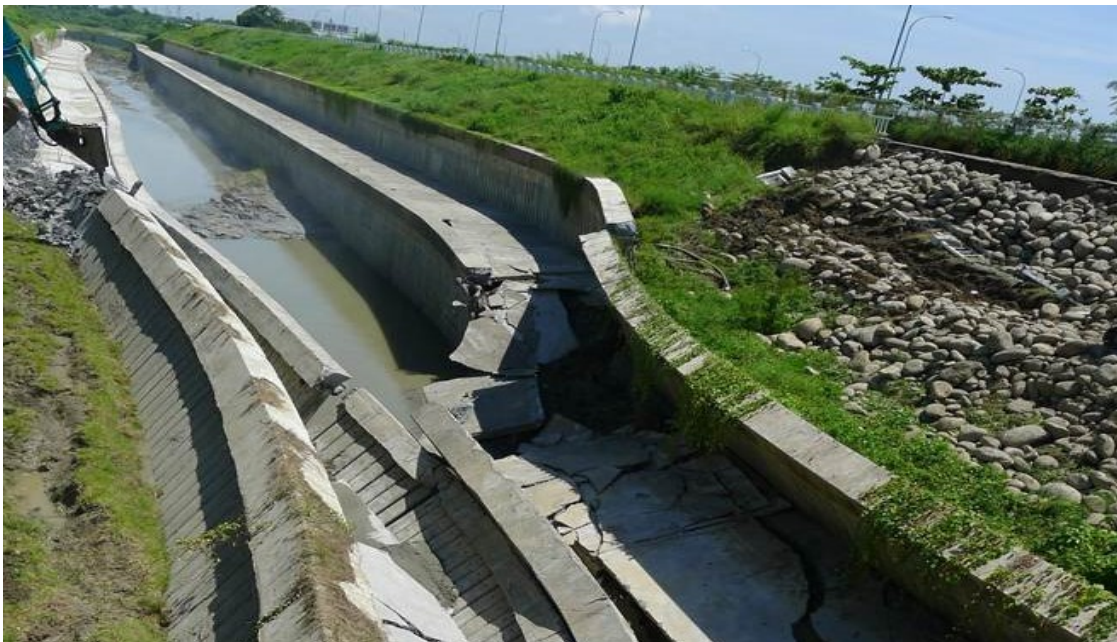
Figure 3. Piping failure of the retaining walls on both sides of the floodway (Gangweigou Creek in Tainan, Taiwan).

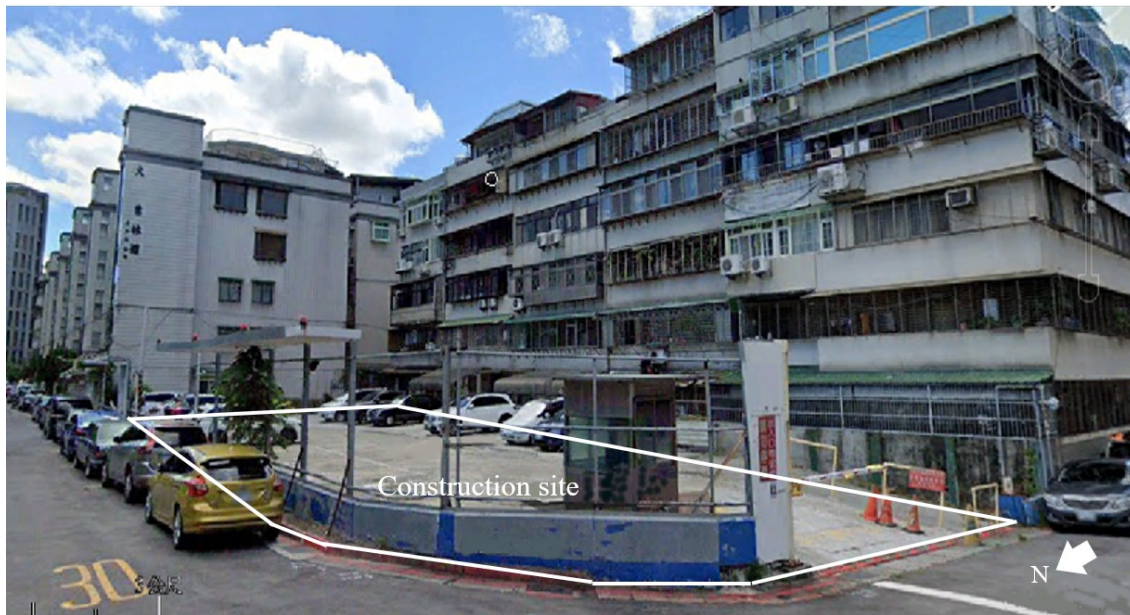
Figure 7 shows the construction site of the Jitai-Dazhi, Taipei, Taiwan, and its adjacent buildings before foun-

ation excavation; it is clear vivid that there are two roads running in different directions and five-story buildings around the construction site.

Figure 7. Construction site and adjacent roads and buildings before foundation excavation of the Jitai-Dazhi site (Taipei, Taiwan) (Google Earth, 2023).

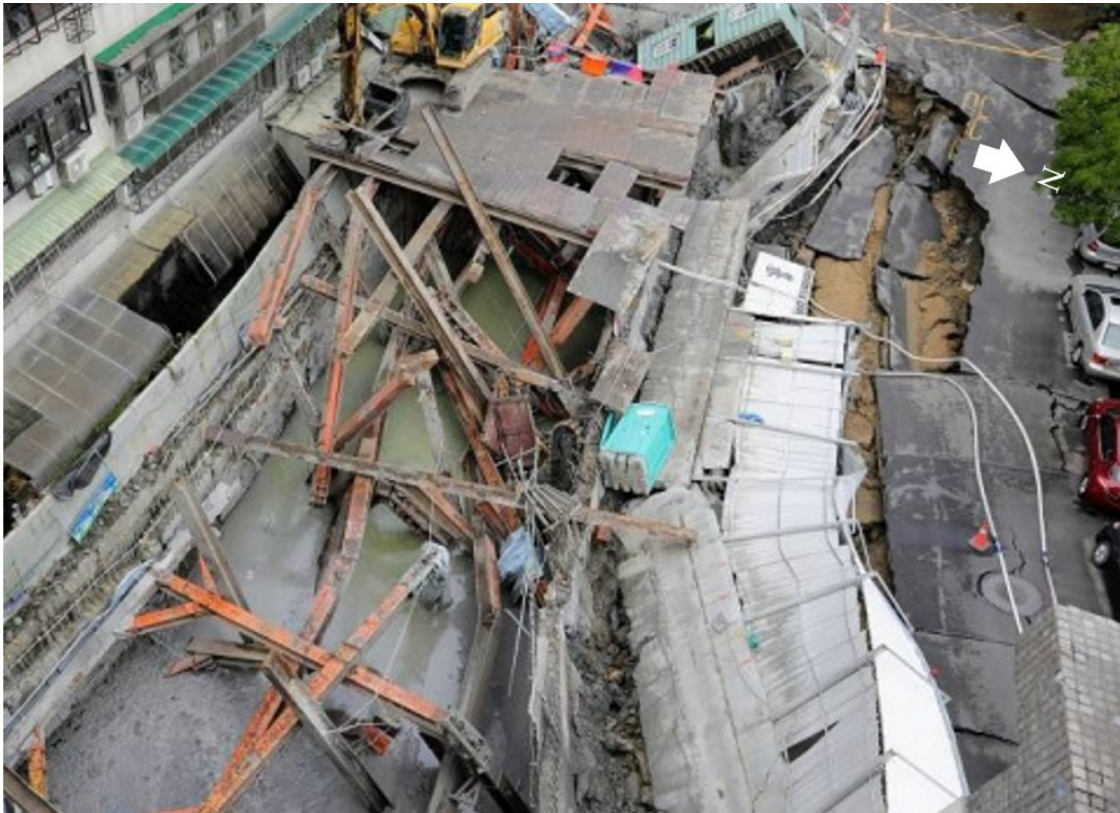
Figure 8 shows the collapse of the slurry wall retaining structure during the foundation excavation of the Jitai-Dazhi site. During the destruction of the slurry wall retaining structure, the slurry wall retaining structure support system was severely damaged. The

Figure 8. Collapsed slurry wall retaining structure of the Jitai-Dazhi site during the foundation excavation.

1) Figure 8 shows that during the excavation of the site of the Dazhi-Jitai, the slurry wall retaining structure collapsed severely. From Figure 8, we can see that the cause of the damage to the slurry wall retaining structure is that a large amount of soil on the back of the retaining wall was lost due to piping in shear bands, and a large piping hole appeared on the back of the slurry wall retaining structure is the topographic features of the

- 3) Figure 8 shows that piping failure occurred not only on the north side but also on the south side during the foundation excavation of the Jitai-Dazhi site.

- 4) When the slurry wall retaining structure on the north side of the Jitai-Dazhi site collapsed because of piping, a large piping hole appeared on the ground surface behind the structure due to substantial soil loss, as illustrated in Figure 8.

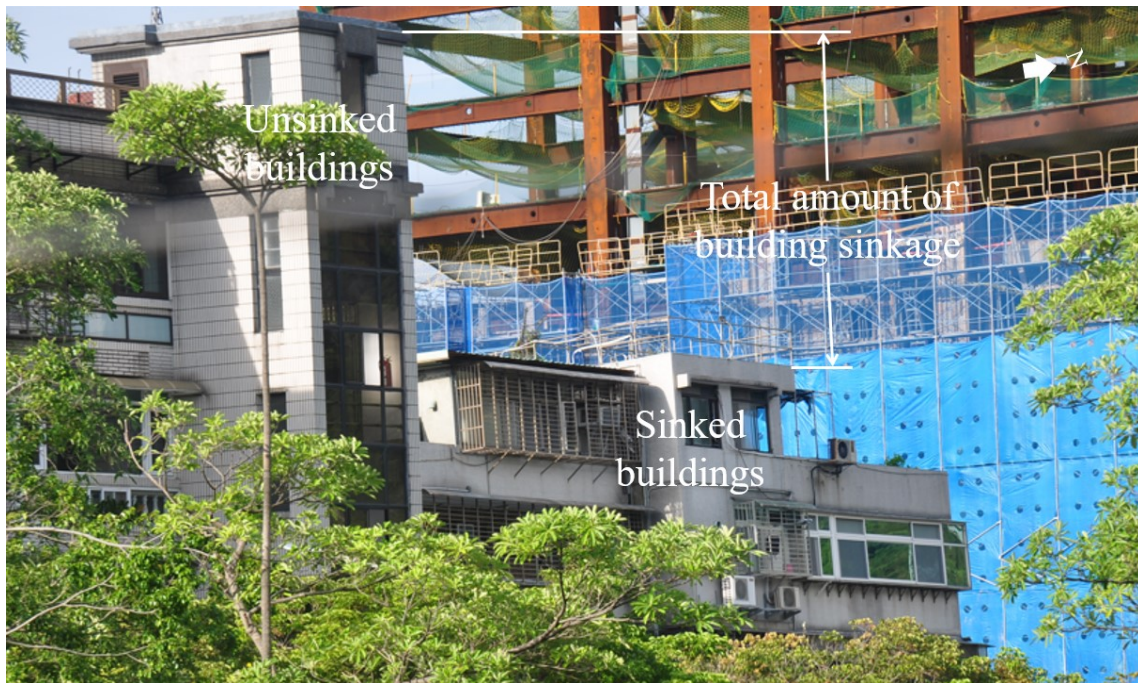
building adjacent to the slurry wall retaining structure subsided notably because of lateral displacement of the foundation soil toward the excavation area, with the total subsidence amounting to approximately the height of one floor (see Figure 9).

Figure 9. Subsidence of the building adjacent to the Jitai-Dazhi site during the foundation excavation.

2) Figure 12(a) shows that before the excavation of site of the Dazhi-Jitai, the building immediately adjacent is five-story; Figures 9 and 12(b) both show that during the excavation of the site of the Dazhi-Jitai, the adjacent building sank significantly and became a four-story building; therefore, during the excavation of the site of the Dazhi-Jitai, the adjacent buildings sank as much as one floor deep.

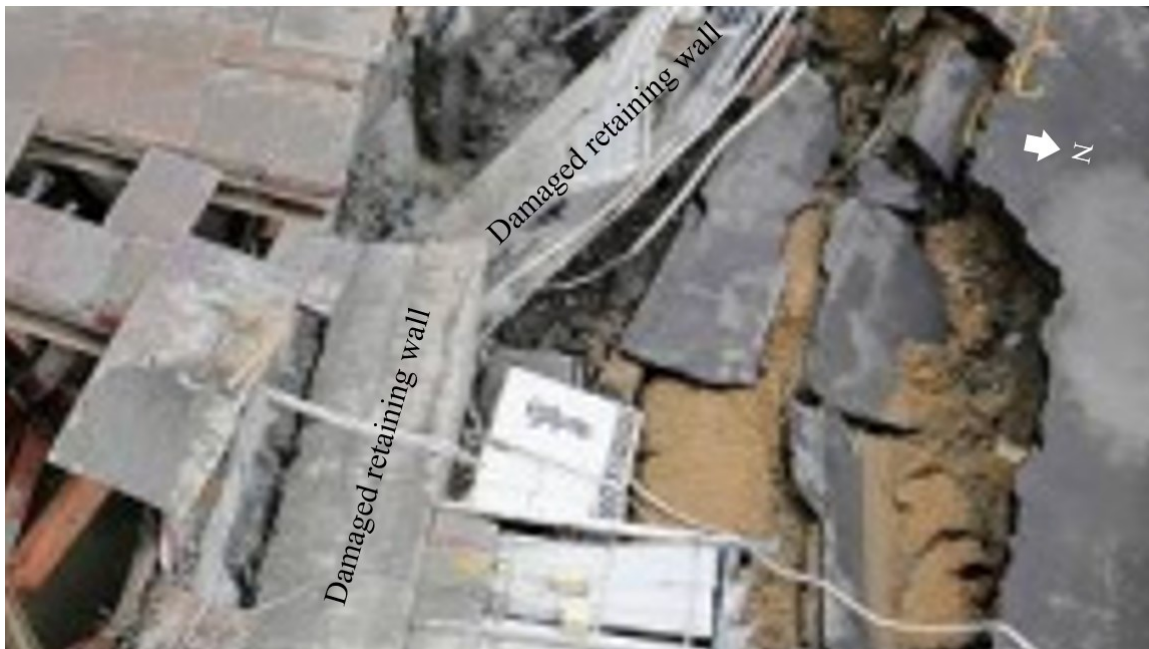
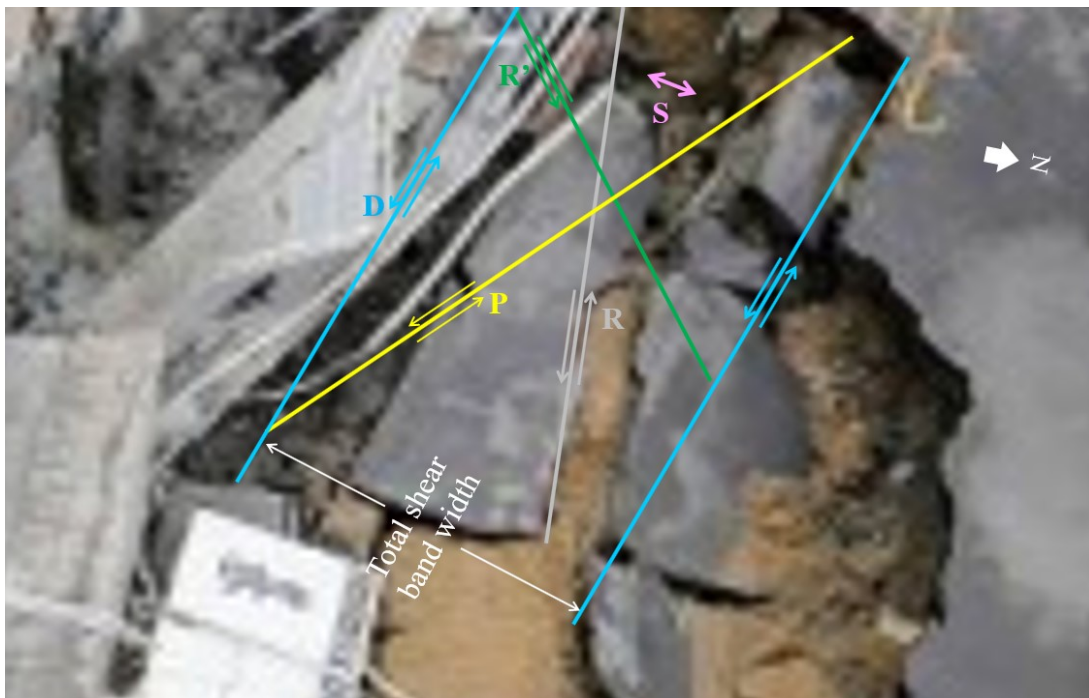
Figure 11. Identifying shear textures using an on-site image.

Figure 11(a) shows an image of the area of the collapsed slurry wall retaining structure. This image, supplemented with various shear textures within the overall shear band width, facilitates the identification of key features. The collapsed area of the slurry wall retaining structure at the Dazhi-Jitai construction site reveals diverse shear textures, depicted in Figures 11(b) and 11(c), with two total shear band widths oriented along different strikes. The shear textures with distinct strikes,

as illustrated in Figure 11(b), encompass principal displacement shear D with a strike of  $N10^{\circ}W$ , thrust shear P with a strike of  $N3^{\circ}E$ , Riedel shear R with a strike of  $N30^{\circ}E$ , conjugate Riedel shear R' with a strike of  $N71^{\circ}W$ , and compression texture S with a strike of  $N79^{\circ}E$ . The shear textures with different trends shown in Figure 11(c) include principal displacement shear D with a strike of  $N72^{\circ}W$ , thrust shear P with a strike of  $N46^{\circ}W$ , Riedel shear R with a strike of  $N86^{\circ}E$ , conjugate Riedel shear R' with a strike of  $N50^{\circ}E$ , and compression texture S with a strike of  $N10^{\circ}E$ .

(a) Before drawing the shear textures

(b) After drawing the shear textures (1)

(c) After drawing the shear textures (2)

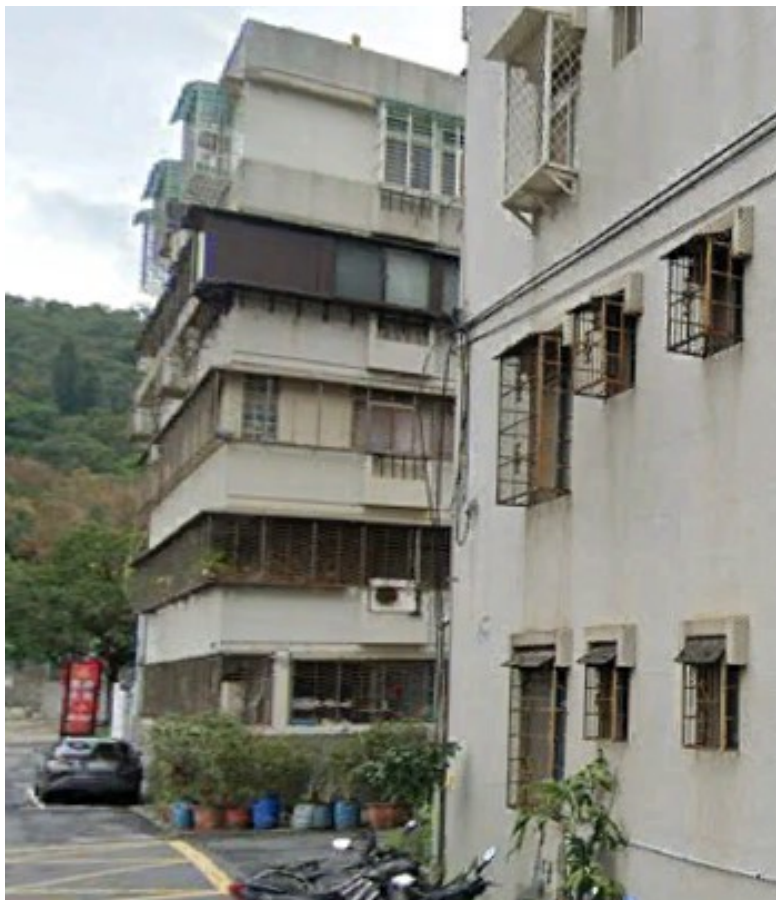
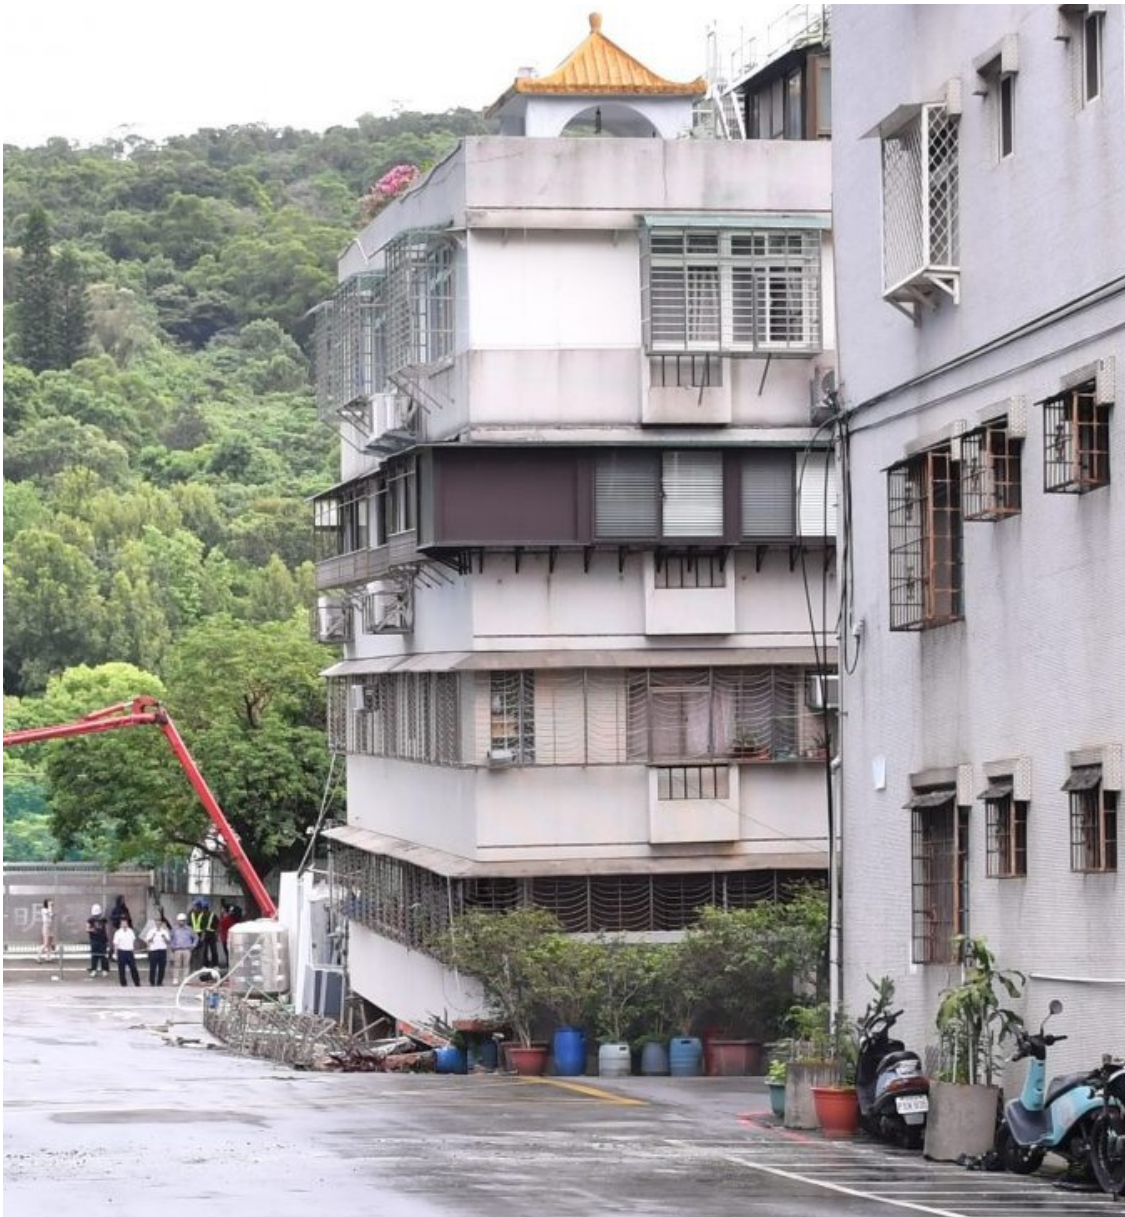
Figure 12. Comparison of the number of floors before and after subsidence of the building adjacent to the Dazhi-Jitai construction site.

(a) Five stories before subsidence (Google Earth, 2023).

(b) Four stories after subsidence
