THE MAJOR CAUSE FOR SLIDING FAILURE OF SIDE WALLS DURING BASEMENT EXCAVATION IN HIGH-RISE BUILDINGS

Tse-Shan Hsu

Lin-Yao Wang

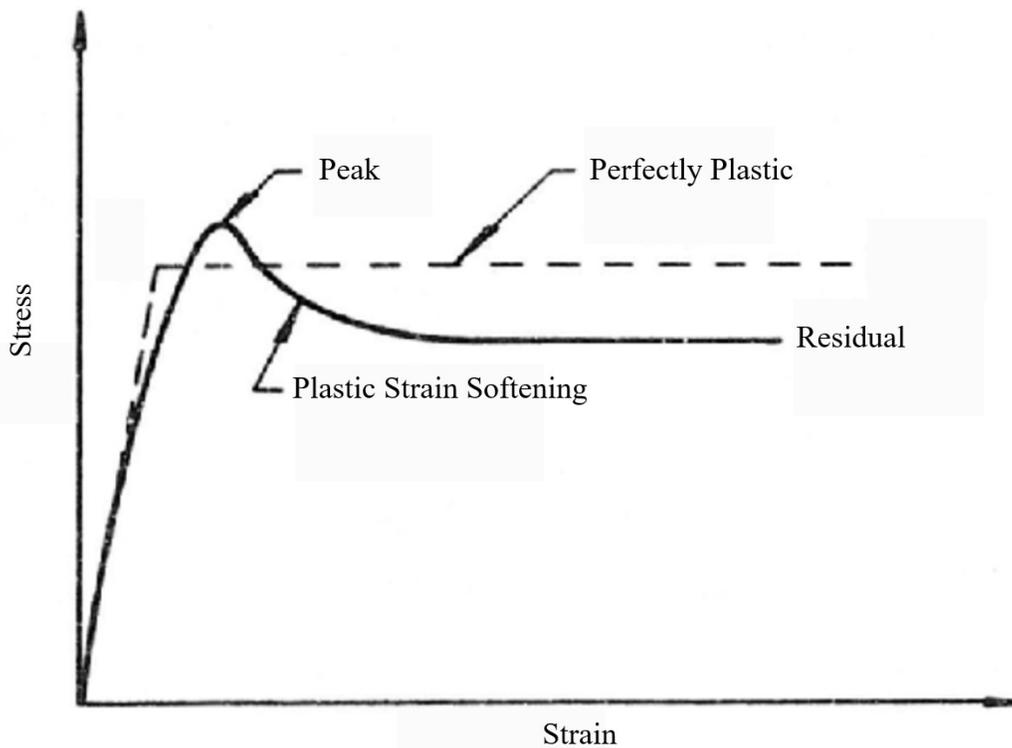
Figure 2. Comparison of the stress-strain relationship curves between actual soil and simplified soil (Chen, 1975).

Research by Hsu, et al. (2021) indicates that Coulomb's formula, derived under stable conditions, does not induce a failure surface in the soil behind retaining walls. In contrast, an unstable plastic strain-softening model would better represent the actual failure conditions.

Hsu, et al. (2021) demonstrated that under both active and passive earth pressure conditions, employing a stable perfectly plastic model does not accurately generate a failure surface within the soil behind a retaining wall. It is only with the use of an unstable plastic strain-softening model that a failure

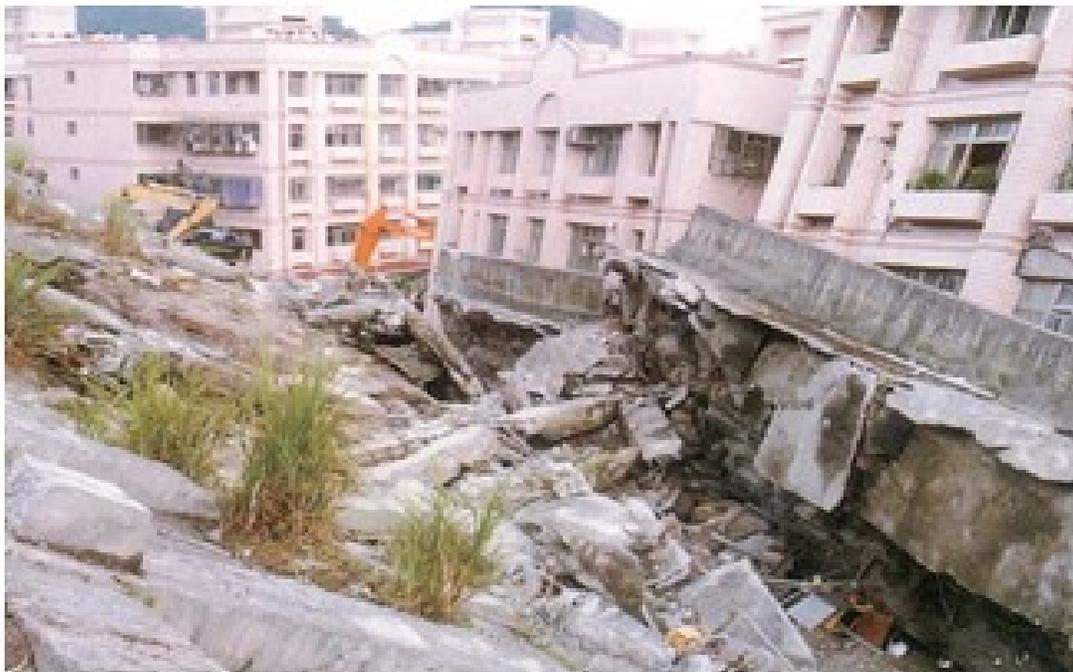
(a) During heavy rainfall (New Taipei City, Taiwan; Hsu et al., 2021)

Figure 3. Failure of retaining walls under various conditions.

of active earth pressure, the Coulomb formula has been shown to cause a substantial overestimation—by a factor of 2.5—due to its reliance on the stable perfectly plastic model rather than the unstable strain-softening model (Hsu, et al, 2021). As a result, retaining walls designed using this formula may be prone to failure under a variety of conditions, including during typhoons, heavy rainfall, earthquakes, or even under calm, dry conditions (see Figure 3).

Due to the inherent incompatibilities in the derivation of earth pressure formulas, retaining walls designed using conventional methods are susceptible to failure. In traditional retaining wall design, when in-situ stress conditions surpass the limit state and result in wall failure, the design outputs often fall short in addressing the extent of the failure, the residual functionality of the wall post-failure, and the acceptable level of wall damage.

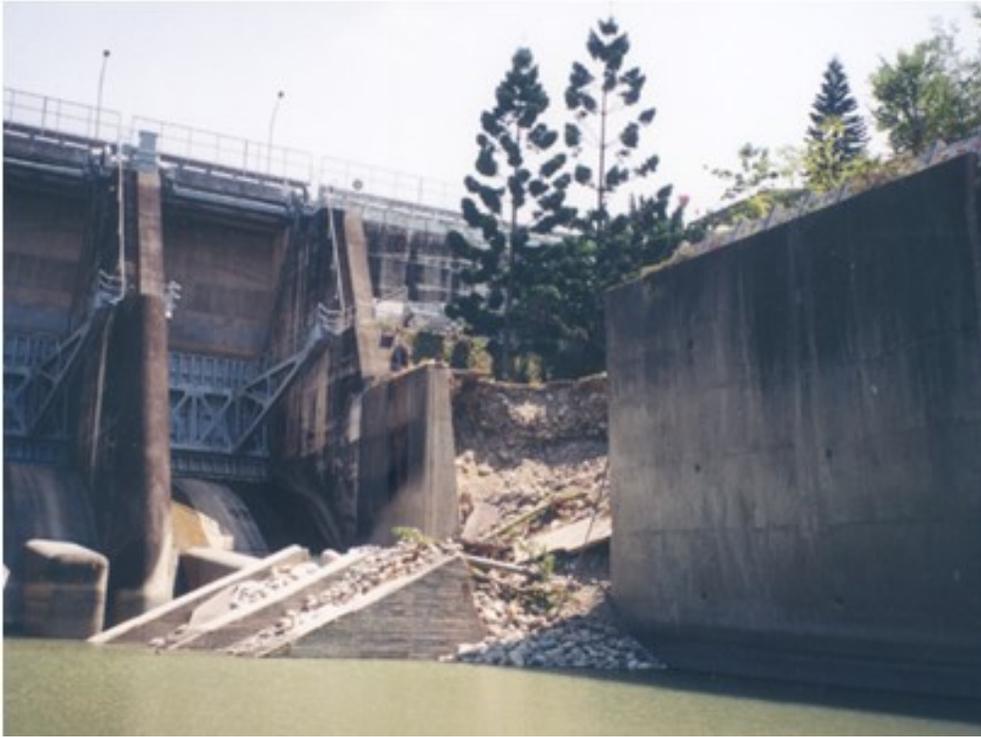
(b) During the 921 Jiji Earthquake (Taichung, Taiwan; Hsu et al., 2021)

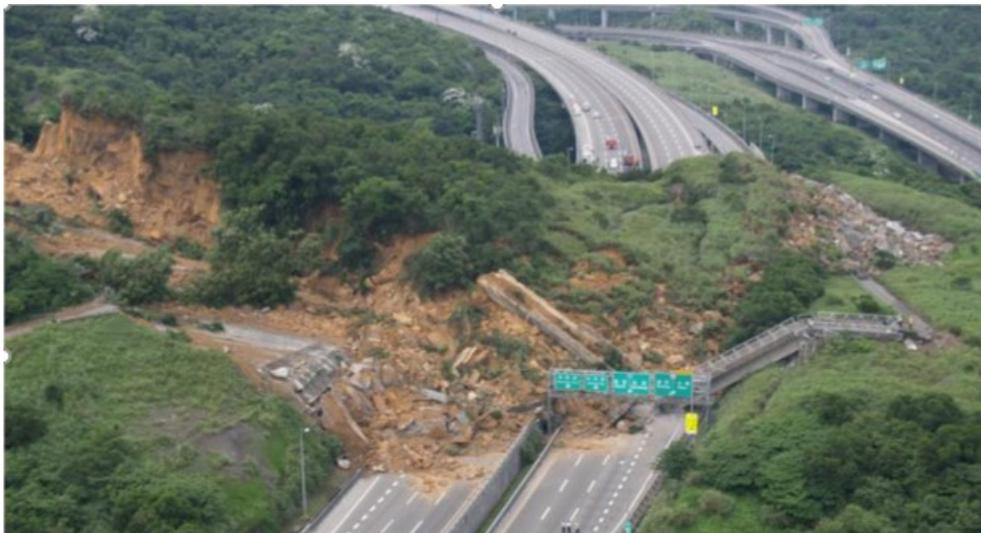
(c) In the absence of wind, rain, and earthquakes (Keelung, Taiwan; Hsu et al., 2021).

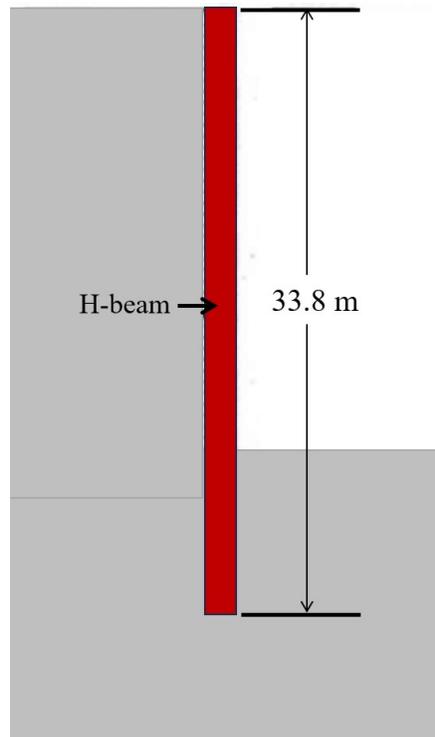
(a) Schematic diagram of H-beam penetration depth into soil layers.

H30 x 30 x 1 x 1.5

(b) Center-to-center distance between two H-beams.

Figure 4. Retaining structures for the Fengcai-520 high-rise basement excavation using traditional design methods

In practice, after selecting the safety factors according to regulations, engineers conduct equilibrium analyses under limit conditions. For example, the retaining structures for the basement excavation of the Fengcai-520 high-rise building are designed as depicted in Figure 4. The design utilizes H-shaped steel sections with dimensions H30 x 30 x 10 x 15, positioned with a center-to-center spacing of 80 centimeters between adjacent sections and a penetration depth of 33.8 meters.

Based on traditional design methodologies, the retaining structures for the Fengcai-520 high-rise basement excavation have been engineered according to the specified safety factors and equilibrium analyses, as illustrated in Figure 4. The design incorporates H-shaped steel sections (H30 x 30 x 10 x 15) with an 80-centimeter center-to-center distance between sections and a penetration depth of 33.8 meters.

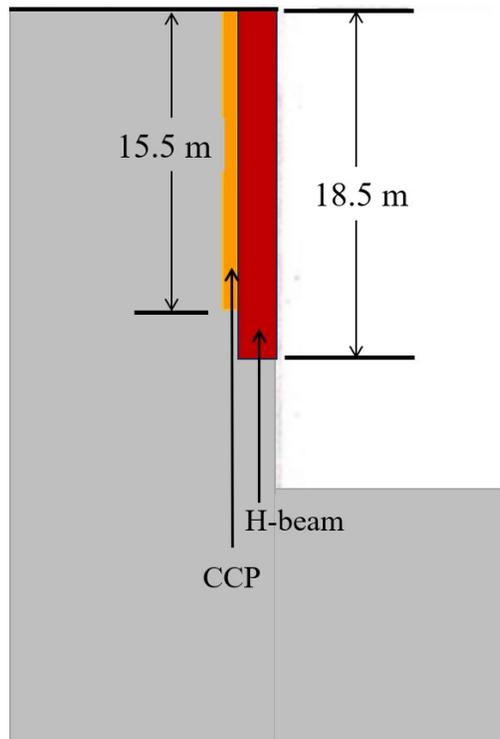
(a) Schematic diagram of H-beam penetration depth and CCP operation depth.

H30 x 30 x 1 x 1.5

(b) Center-to-center distance between two H-beams.

Figure 5. Retaining structures for the Fengcai-520 high-rise basement excavation using performance-based design methods

tical stability. By applying performance-based design principles and engineering judgment, more effective solutions can be achieved. For example, as shown in Figure 5, the design incorporates H-shaped steel sections (H30 x 30 x 10 x 15) with an 80-centimeter center-to-center spacing between adjacent sections and a penetration depth of

18.5 meters. Additionally, within a depth range of 15.5 meters, high-pressure jet grouting (CCP) is employed to inject a special cement slurry into the underground formation. This process rapidly consolidates the formation to create a strong, impermeable cut-off barrier, effectively reducing groundwater flow in shear bands.

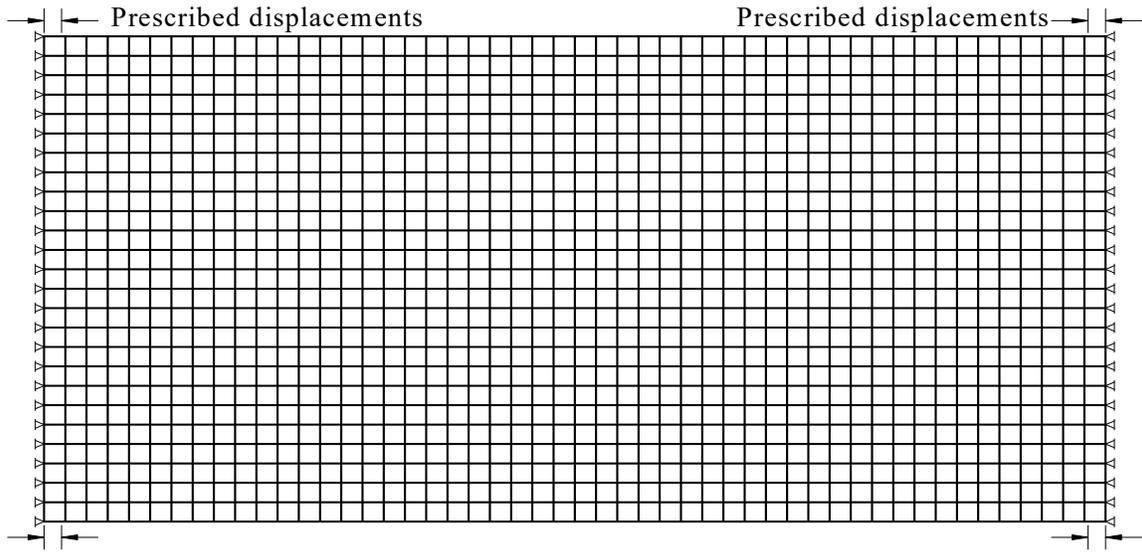
Figure 6. Finite element mesh, boundary conditions and prescribed lateral displacements (Hsu, 1987)

Figure 6 depicts the finite element mesh of a plate subjected to continuous lateral compression. Figure 7 illustrates the deformation patterns that emerge when the strain in the plate enters the plastic range, resulting in localized deformations due to strain softening and the formation of shear bands within the finite element mesh. Figure 8 shows the contour map of excess pore water pressure within the groundwater underlying this plate. As indicated in Figure 7, shear banding during a seismic event leads to a highly concentrated excess pore water pressure within the shear bands.

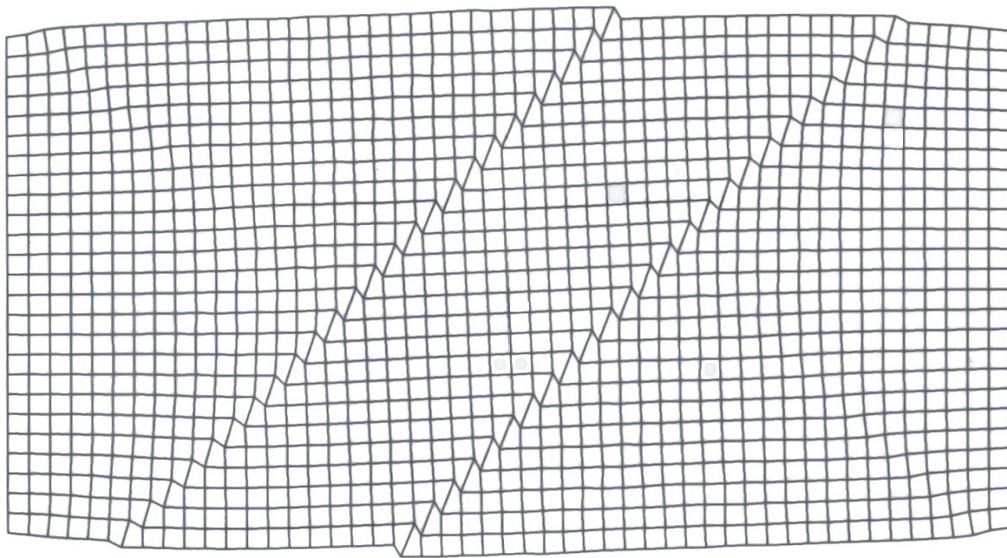
Figure 7. Deformed finite element mesh (Hsu, 1987)

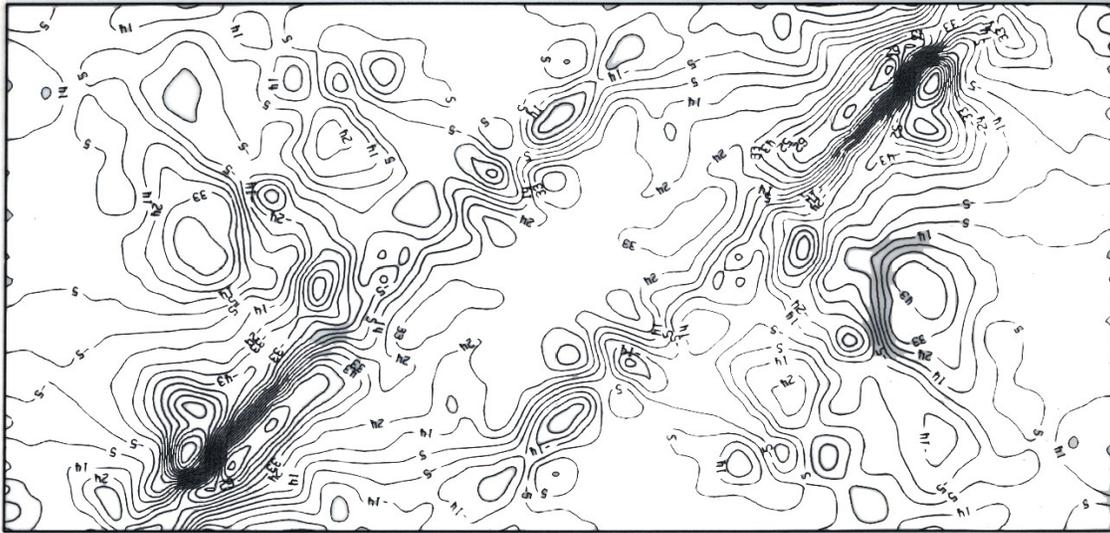
Figure 8. Contours of excess pore water pressures (Hsu, 1987)

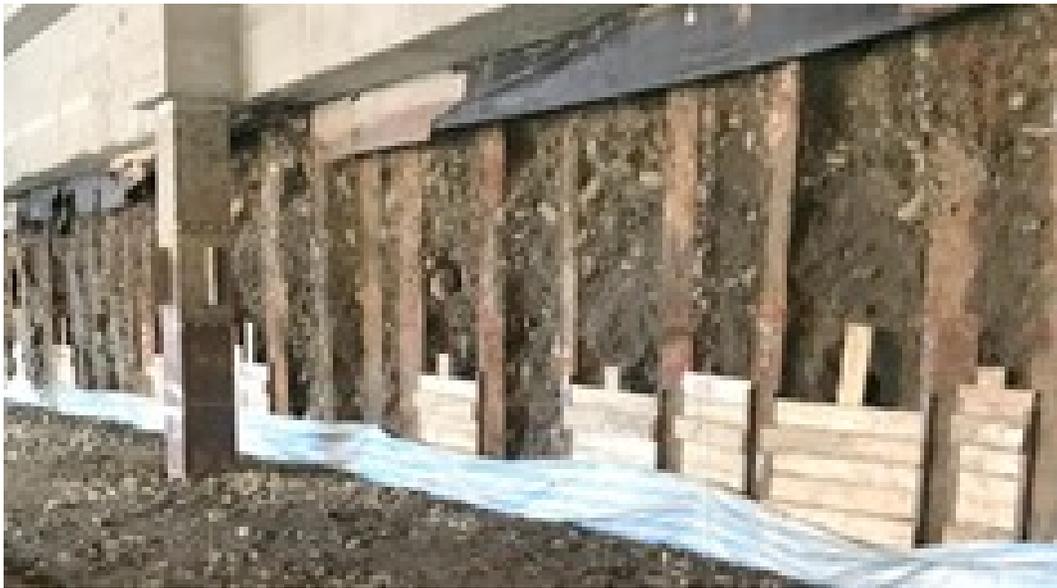
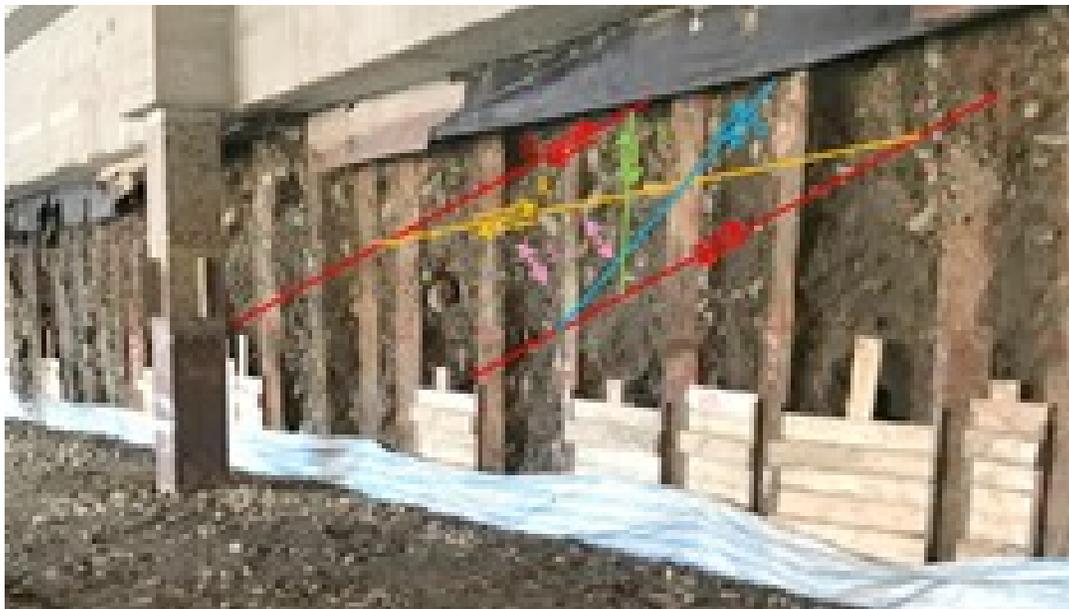
1. Figure 9 illustrates the shear textures within the total shear band width in the dense silty gravel layer

situated between two H-beams. The shear textures depicted include: principal displacement shear (D), thrust shear (P), Riedel shear (R), conjugate Riedel shear (R'), and compression texture (S).

(a) Before overlay.

(b) After overlay

Figure 9. Shear Bands and Shear Structures in the Dense Silty Gravel Layer Between Two H-Beams.

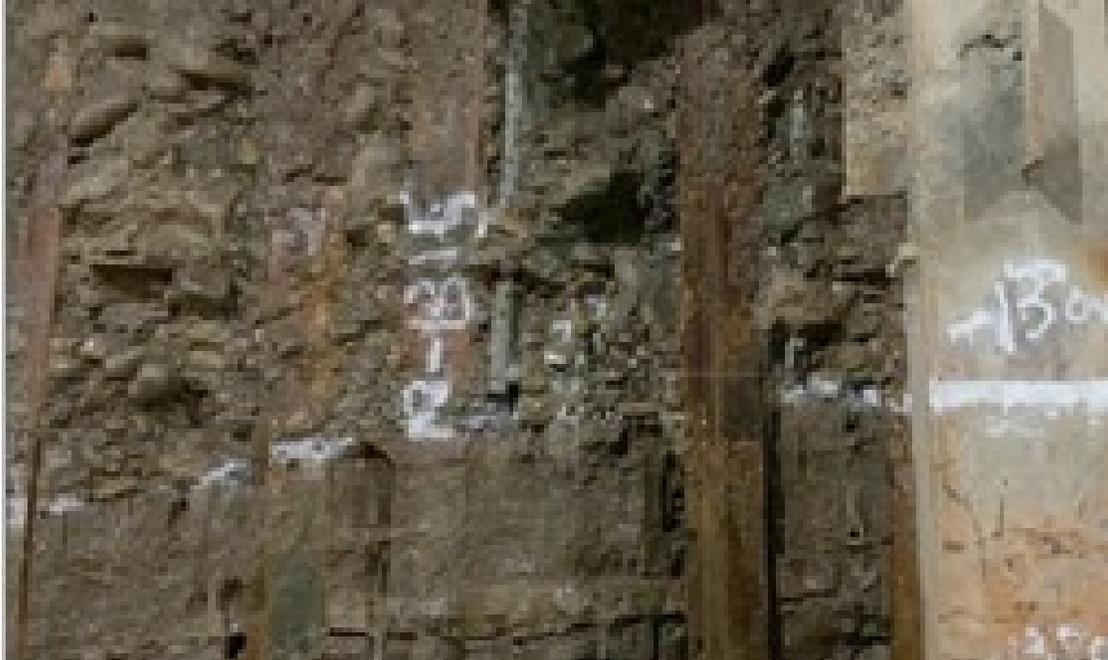
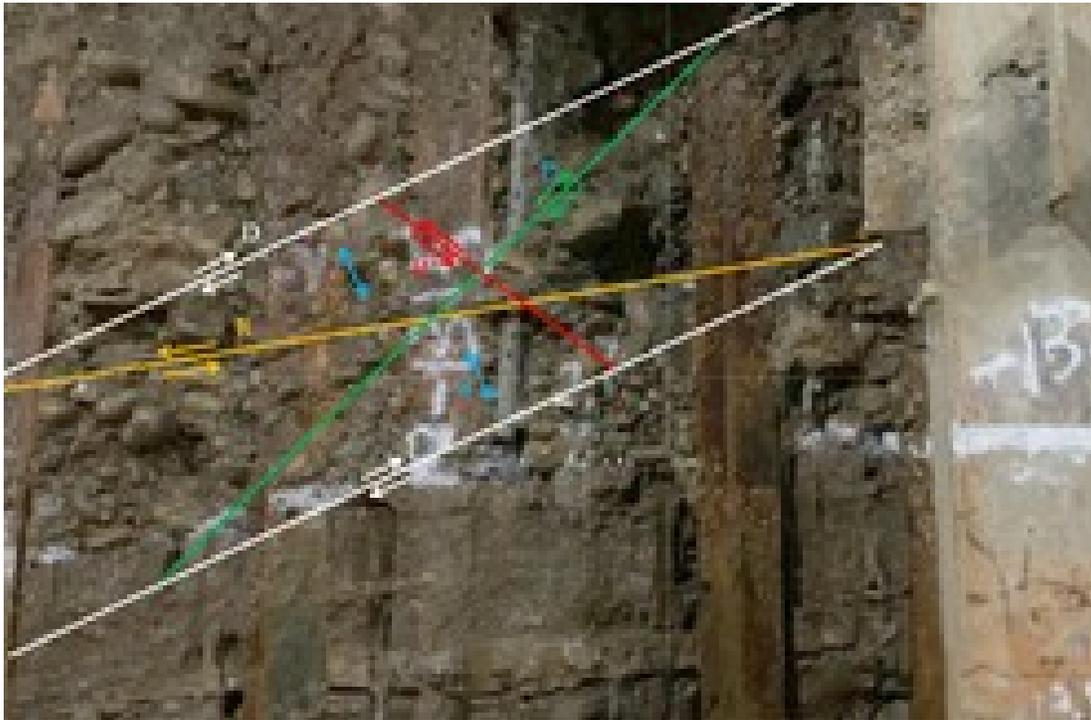
2. Figure 10 shows five distinct groups of shear textures within the total shear band width in the dense

silty gravel layer directly above the two H-shaped steel sections. These shear textures include: principal

displacement shear (D), thrust
shear (P), Riedel shear (R), conju-

gate Riedel shear (R'), and com-
pression texture (S).

Figure 10. Shear fracture zones and structures within the compact silty gravel layer directly above the rock strata between two H-beams.

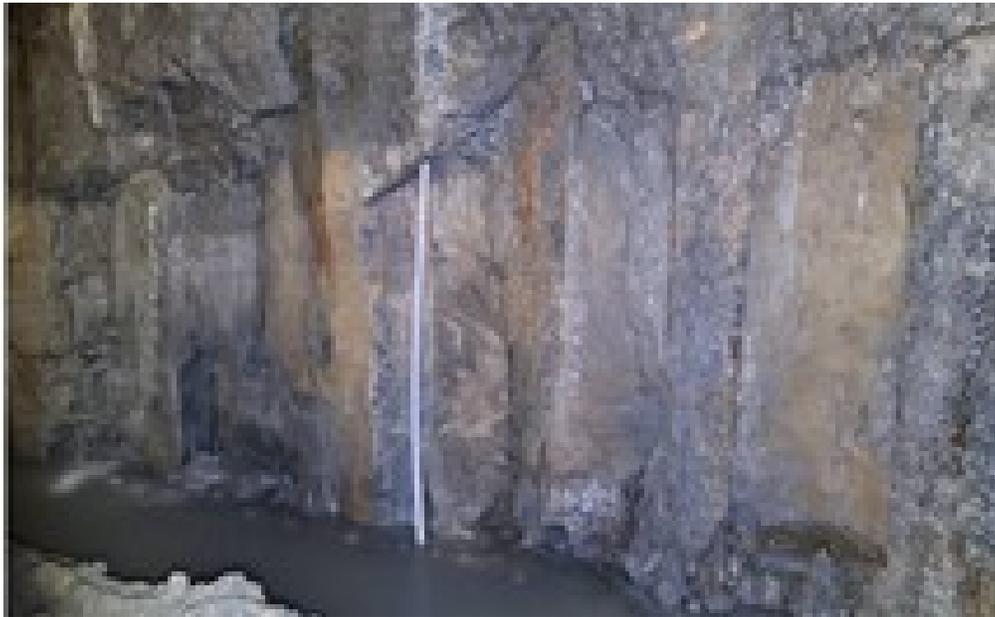
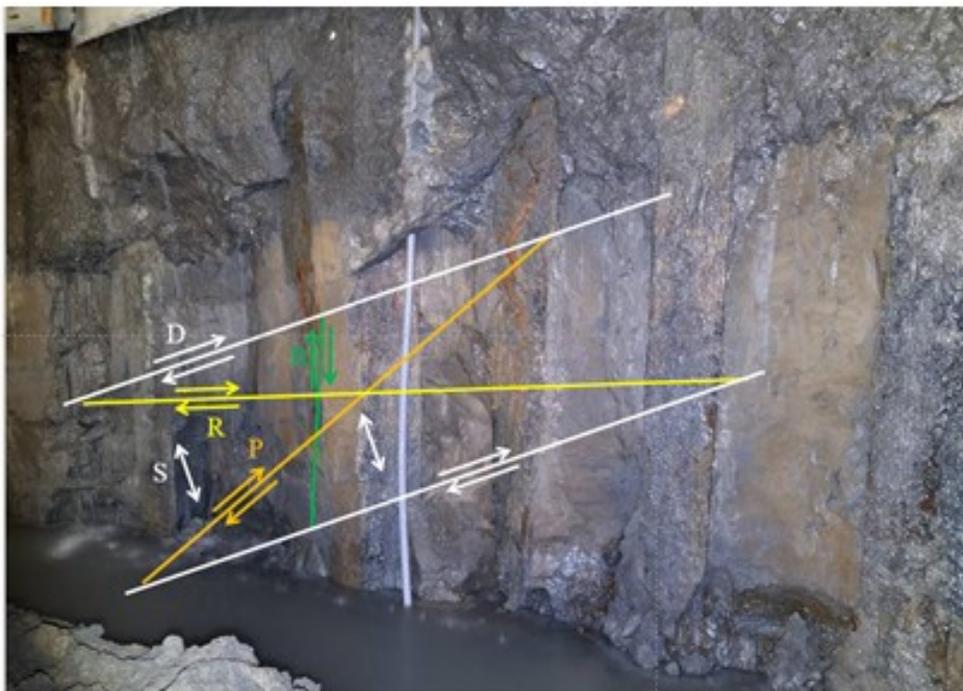
3. Figure 11 displays five distinct groups of shear textures within the total shear band width of an interbedded mudstone and sandstone layer situated between two H-beams. The shear textures illustrated are: principal displacement shear (D), thrust shear (P), Riedel shear (R), conjugate Riedel shear (R'), and compression texture (S).

Figure 11. Shear fracture zones and structures within an interbedded mudstone and sandstone layer between two H-beams.

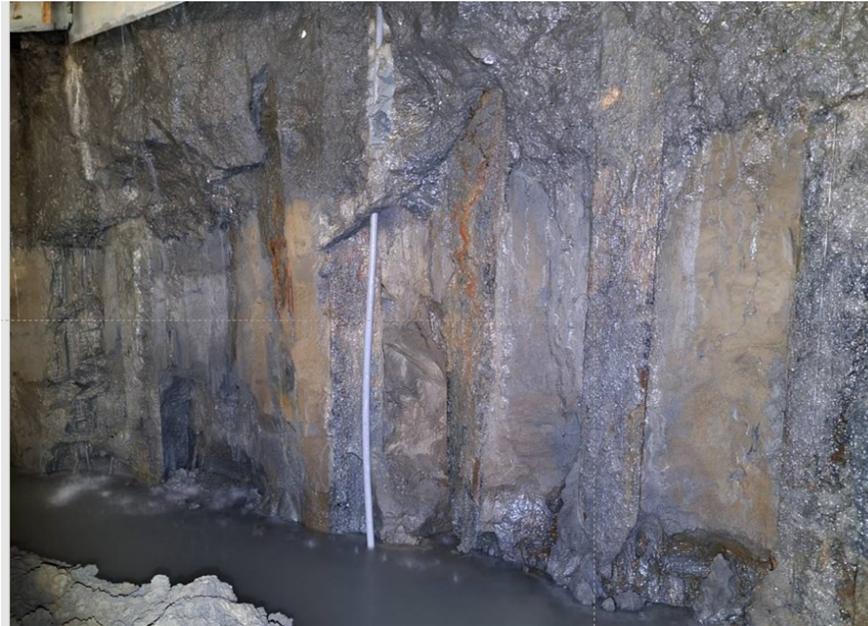
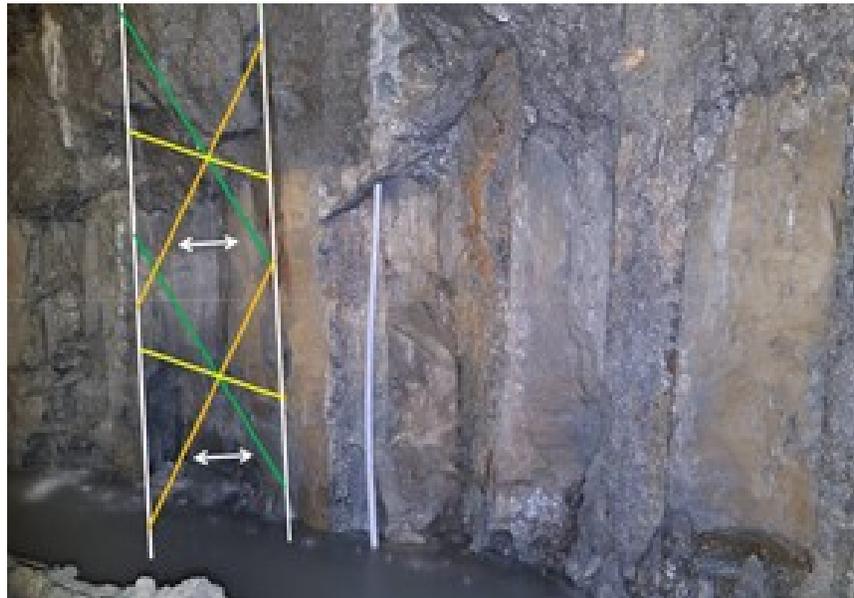
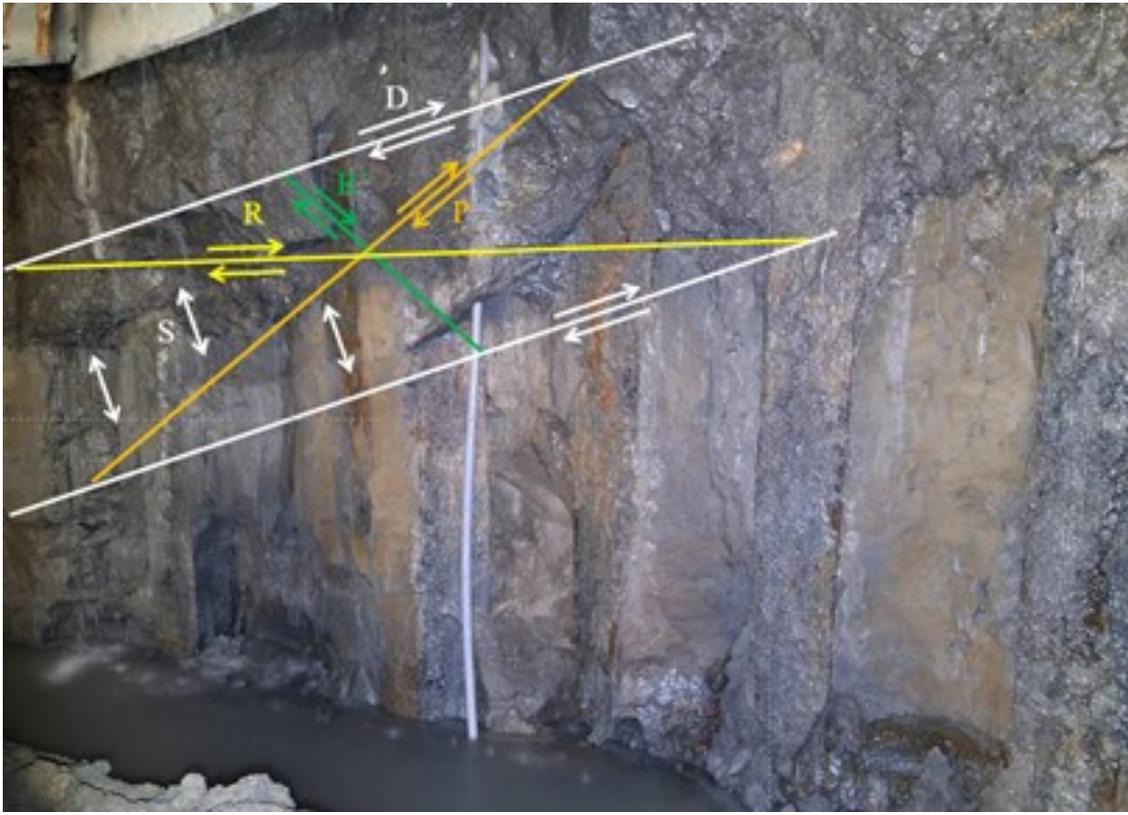
4. Figure 12 illustrates five distinct groups of shear textures within the total shear band width of a second interbedded mudstone and sandstone layer situated between two H-

beams. The shear textures depicted are: principal displacement shear (D), thrust shear (P), Riedel shear (R), conjugate Riedel shear (R'), and compression texture (S).

Figure 12. Shear fracture zones and structures within a second interbedded mudstone and sandstone layer between two H-beams.

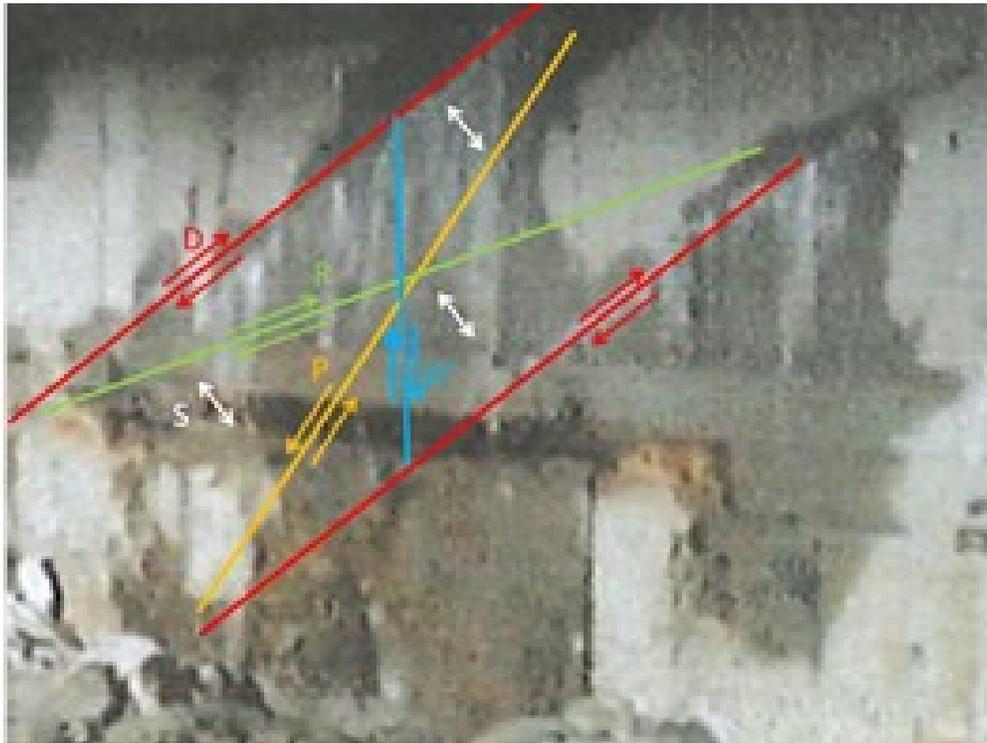
5. Figure 13 illustrates five distinct groups of shear textures within the total shear band width of the rock sidewall on the west side of underground level six. The shear textures shown include: principal displacement shear (D), thrust shear (P), Riedel shear (R), conjugate Riedel shear (R'), and compression texture (S).

Figure 13. Shear fracture zones and structures within the rock sidewall on the west side of the underground level six.

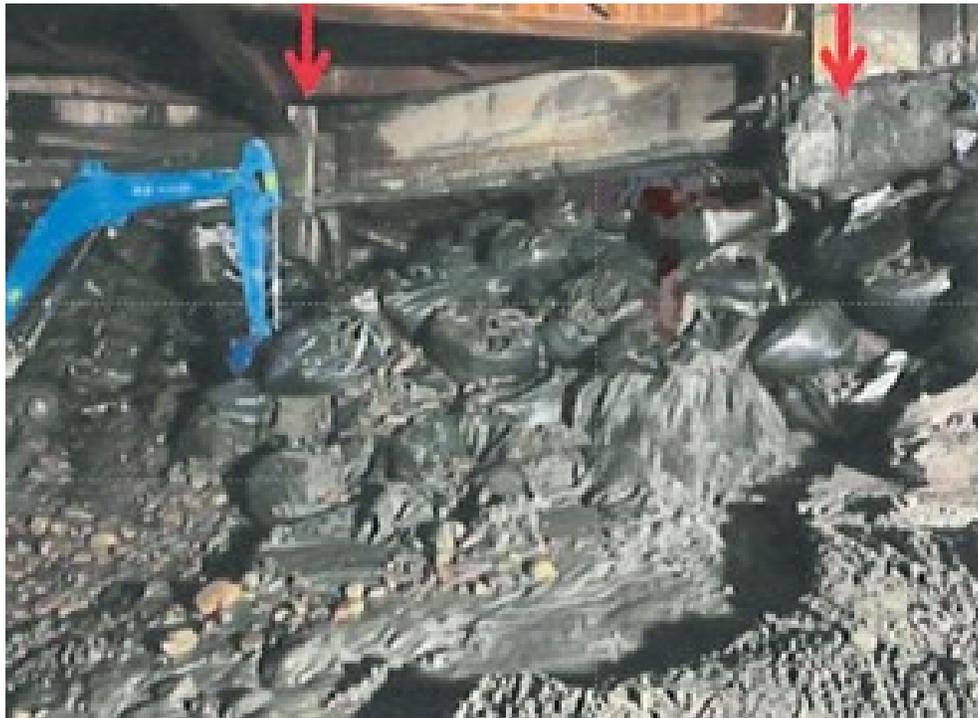
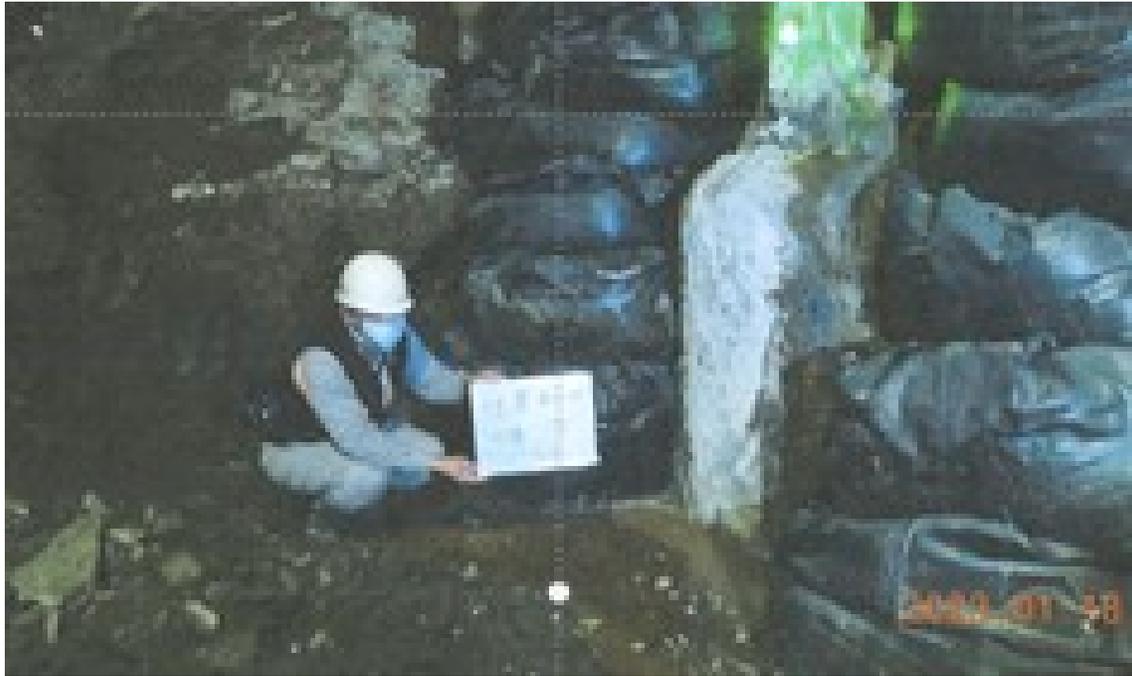
(a) Emergency stabilization of sliding with sandbags and water sealing with CCP (1).

(b) Emergency stabilization of sliding with sandbags and water sealing with CCP (2)

Figure 14. Performance design for emergency treatment of sliding failures on the basement sidewall.

In the event of such sliding failures in the basement's side walls, on-site engineers can implement emergency response measures according to the strategies outlined in the performance-based design. The immediate response involves stabilizing the sliding failure by placing sandbags. Following this, high-pressure grouting operations, specifically using Cemented Column Pipe (CCP) techniques, are performed to construct a cut-off wall (refer to Figures 14(a) and 14(b)).

Emergency stabilization measures, including the use of sandbags and Cemented Column Pipe (CCP) techniques, effectively addressed both the sliding failures and water ingress issues. Following the successful stabilization, construction of the reinforced concrete exterior walls commenced. Figure 15(a) shows the completed reinforced concrete exterior wall on the south side of

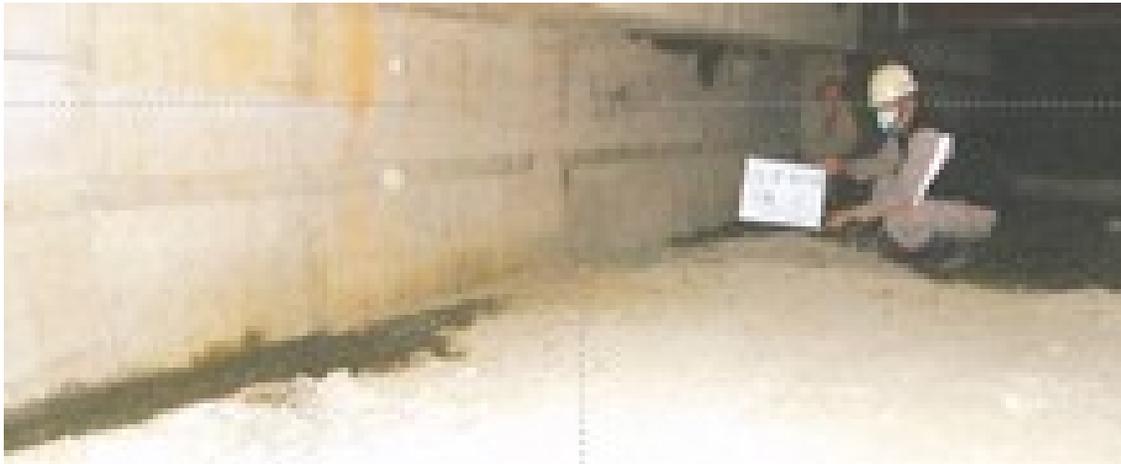
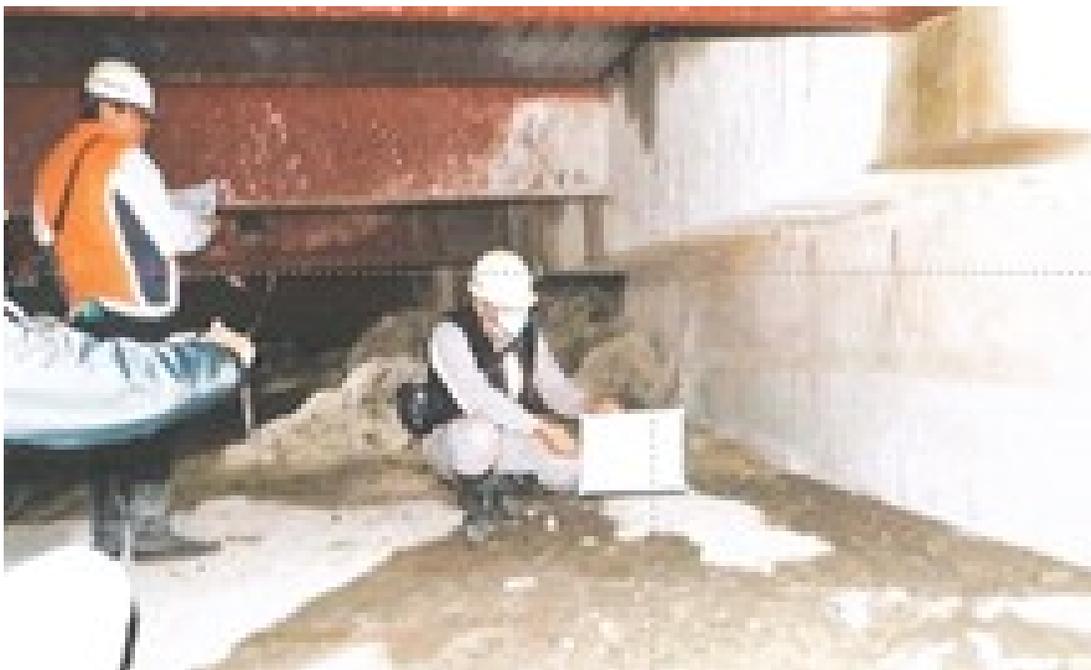
(a) Reinforced concrete exterior wall on the south side of the underground level six.

(b) Reinforced concrete exterior wall on the east side of the underground level six.

Figure 15. Completed reinforced concrete exterior walls on the south side and east side of the underground level six, after resolving sliding issues.

underground level six, while Figure 15(b) depicts the completed reinforced concrete exterior wall on the east side of the same level. These figures illustrate that, after resolving the localized sliding issues along the basement sidewalls, the construction of the reinforced concrete exterior walls for the underground levels could proceed as planned. The completion of these walls demonstrates that the performance design objectives were successfully achieved.

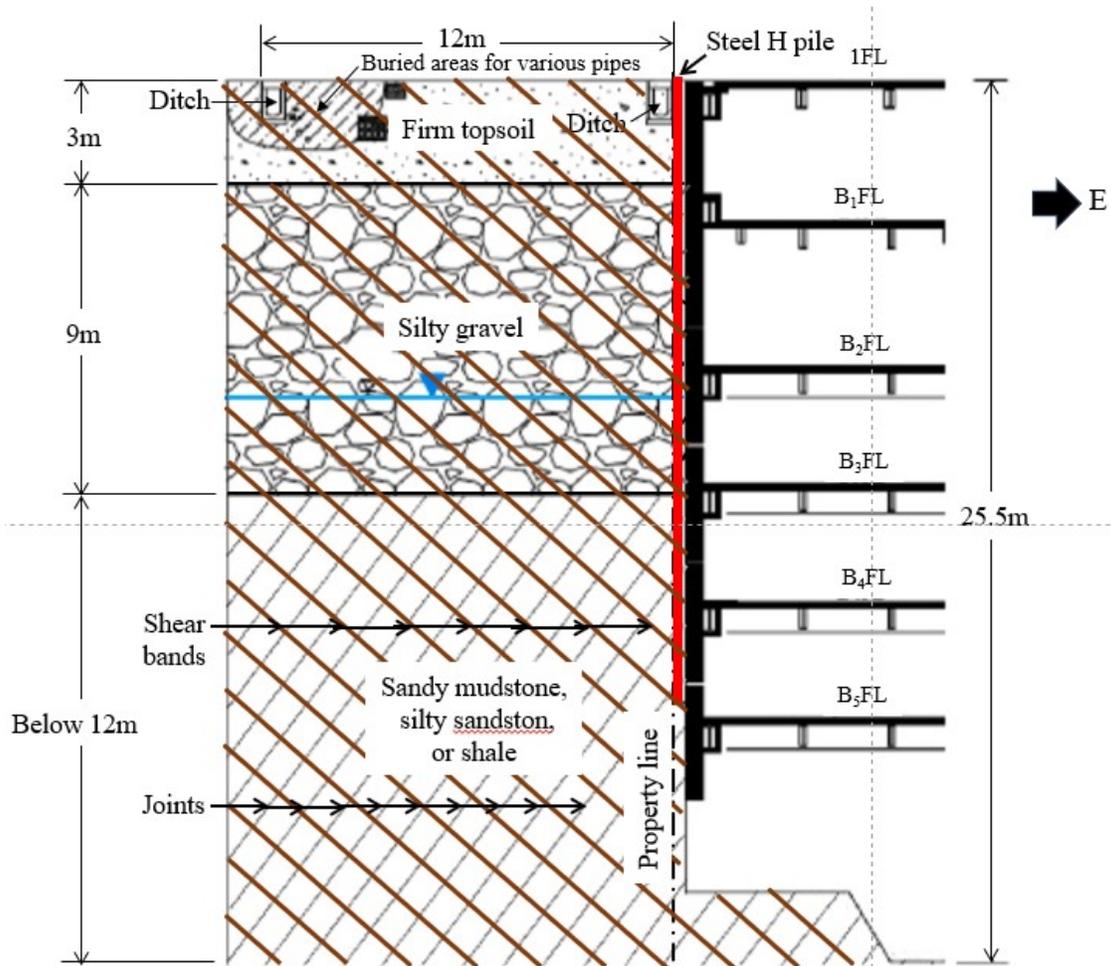
1. Figure 16 presents a schematic of the shear bands adjacent to the basement of the Fongcai-520 high-rise. These shear bands are influenced by shear banding effects typical of Zhubei City, Taiwan. As

tectonic plates undergo lateral compression, strain that progresses into the plastic range results in strain softening. This process induces localized deformations, leading to the formation of shear bands, as illustrated in Figure 6.

Figure 16. Schematic of shear bands adjacent to the basement of the Fengcai-520 high-rise.

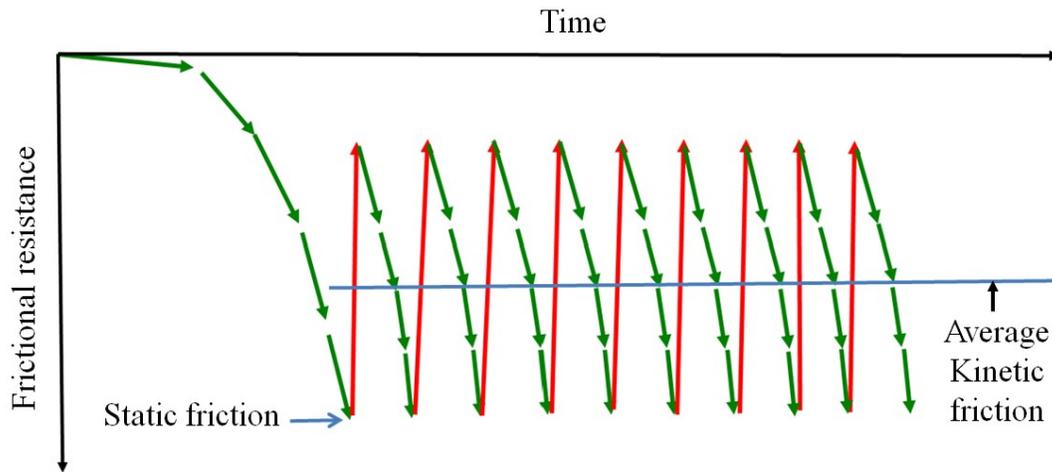
Figure 18. Stick-slip phenomenon in shear bandings
(redrawn from Lambe and Whitman (1969))

celeration. This repeated slip-stick behavior leads to fluctuations between acceleration and deceleration. Consequently, during repeated tectonic earthquakes, shear banding is associated with acceleration-time curves of ground vibrations, as shown in Figure 19. .

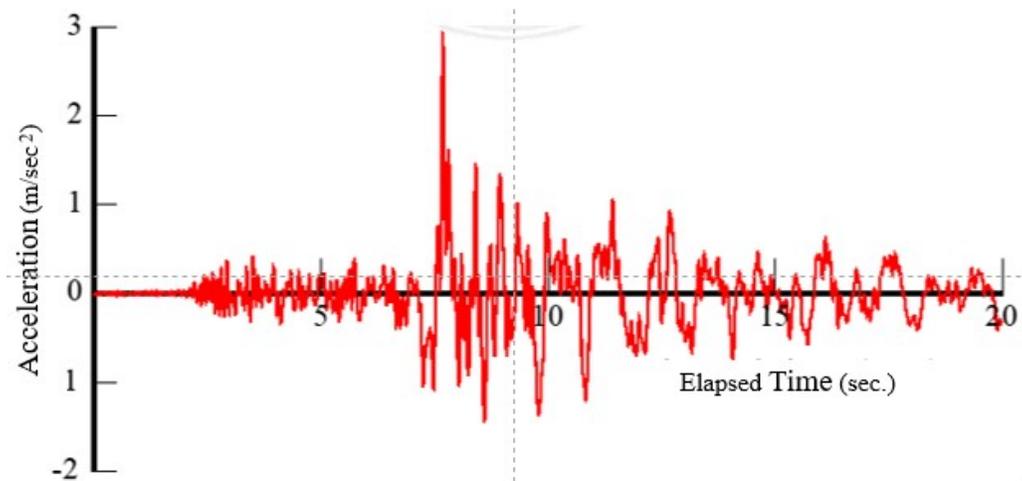
Figure 19. Ground acceleration time-history curve of the seismometer record
