## THE MAJOR CAUSE OF BUILDING FAILURE IN THE REGION AFFECTED BY THE TURKEY-SYRIA EARTHQUAKE

Tse-Shan Hsu

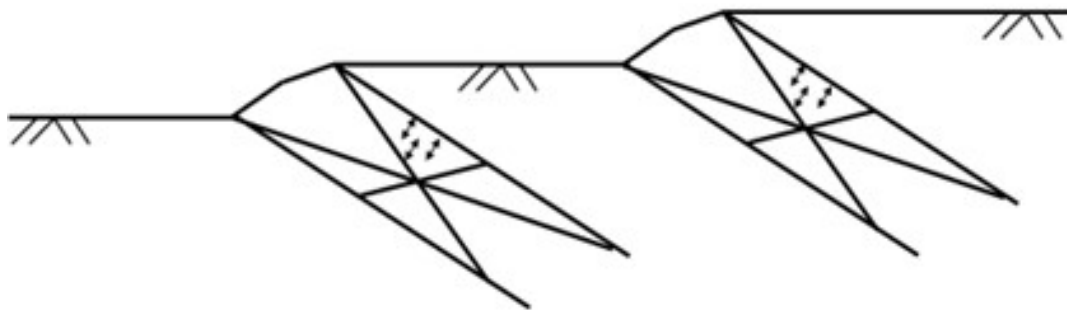
(a) Multiple-step tilted shear banding and uplift slopes

Figure 7 shows the Guangfu Junior High School in Taichung, Taiwan that collapsed in the 921 Jiji earthquake in 1999. Figure 8(a) illustrates two stages of shear banding, involving tilting and uplift slopes before construc-

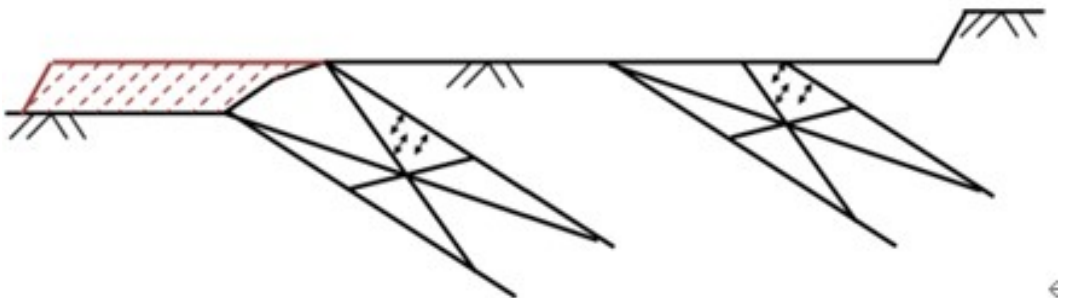
(b) Ground leveling

tion. As illustrated in Figure 8(b), the site was leveled by cutting and filling during the construction process, but two shear bands persisted below the site after leveling. As shown in Figure 8(c), the school building was constructed on the leveled surface. The school building collapsed because of shear banding during the 921 Jiji earthquake, as shown in Figures 7 and 8(d).

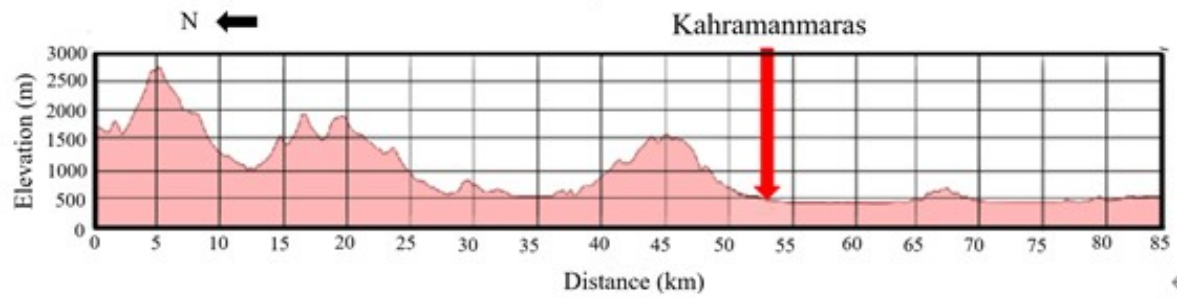
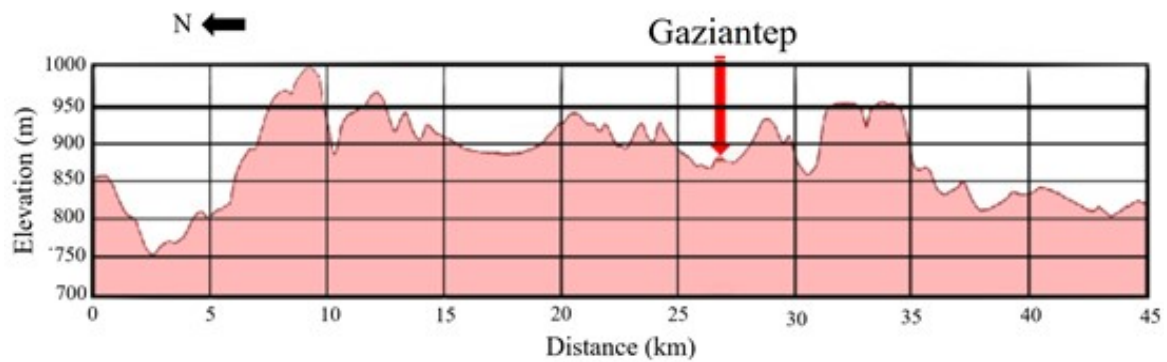
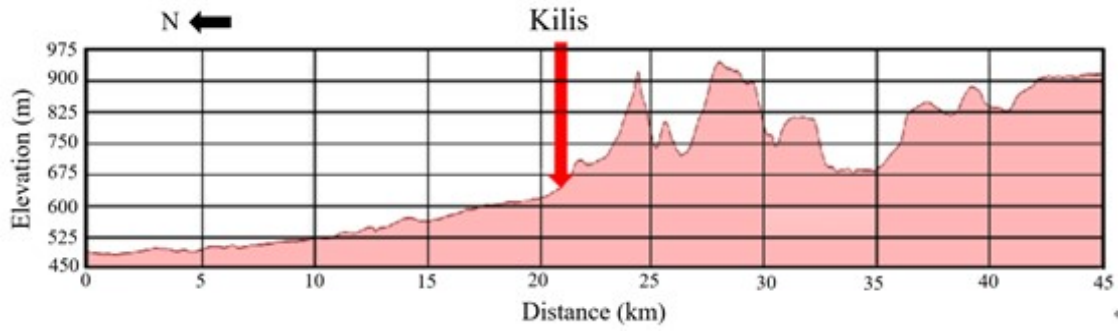
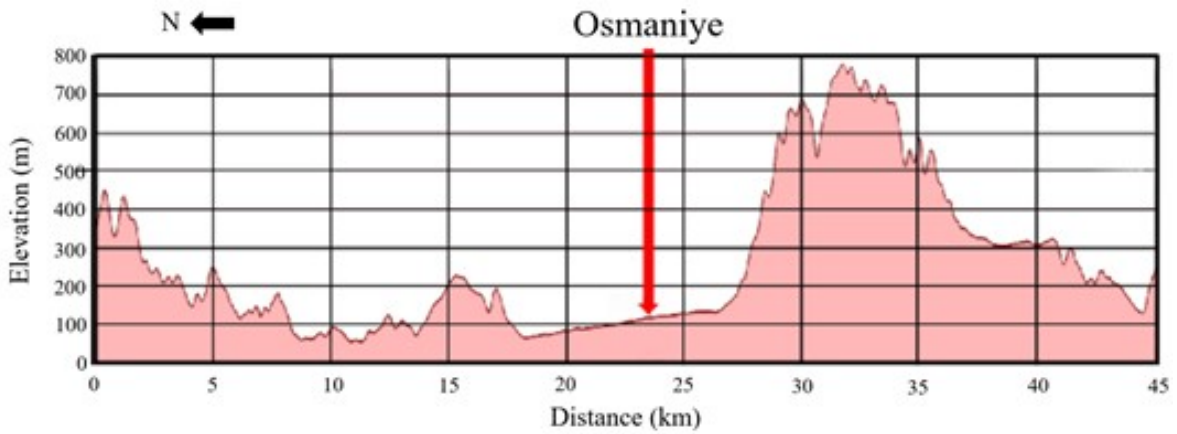
Figure 11. Elevation profiles of the four provinces of the Turkey-Syria earthquake-stricken area (Google Earth, 2019).

Figure 10 shows the epicenter of the Turkey-Syria earthquake and its four neighboring provinces, namely Kahramanmaras, Gaziantep, Kilis, and Osmamiye, where notable building failures occurred. Figures 11(a)–11(d) show the elevation profiles of the four provinces, indicating multi-step shear banded, tilted, and uplifted slopes in these areas. Moreover, buildings similar to those shown in Figure 12 are situated on such slopes in these four provinces.
