## MAJOR CAUSE OF FALL FAILURE OF MARKET BUILDINGS DURING TECTONIC EARTHQUAKES

Tse-Shan Hsu

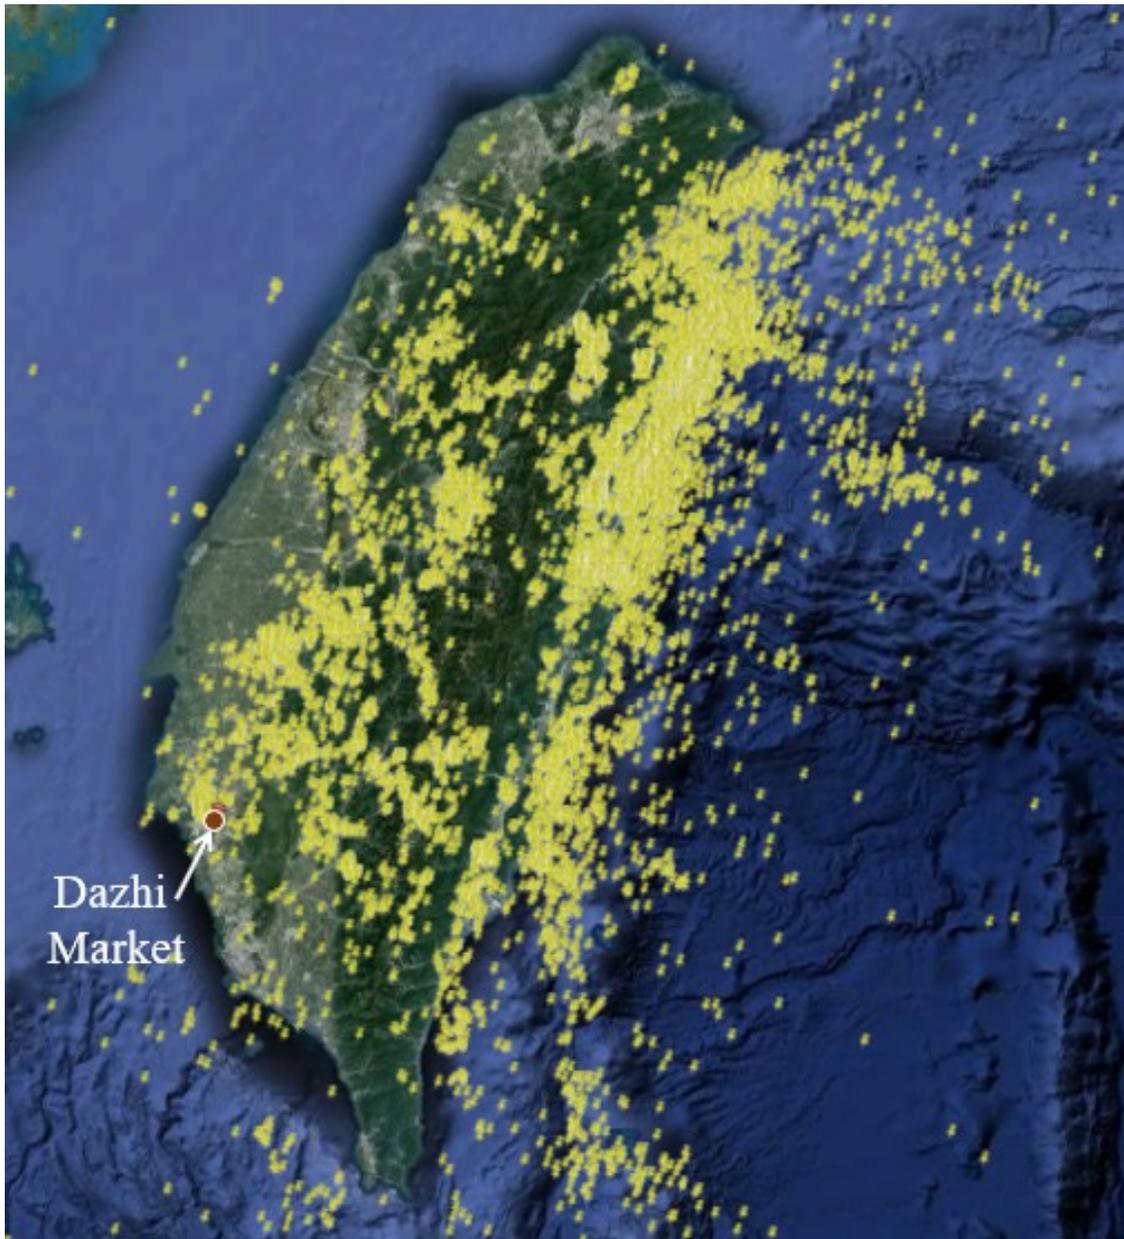
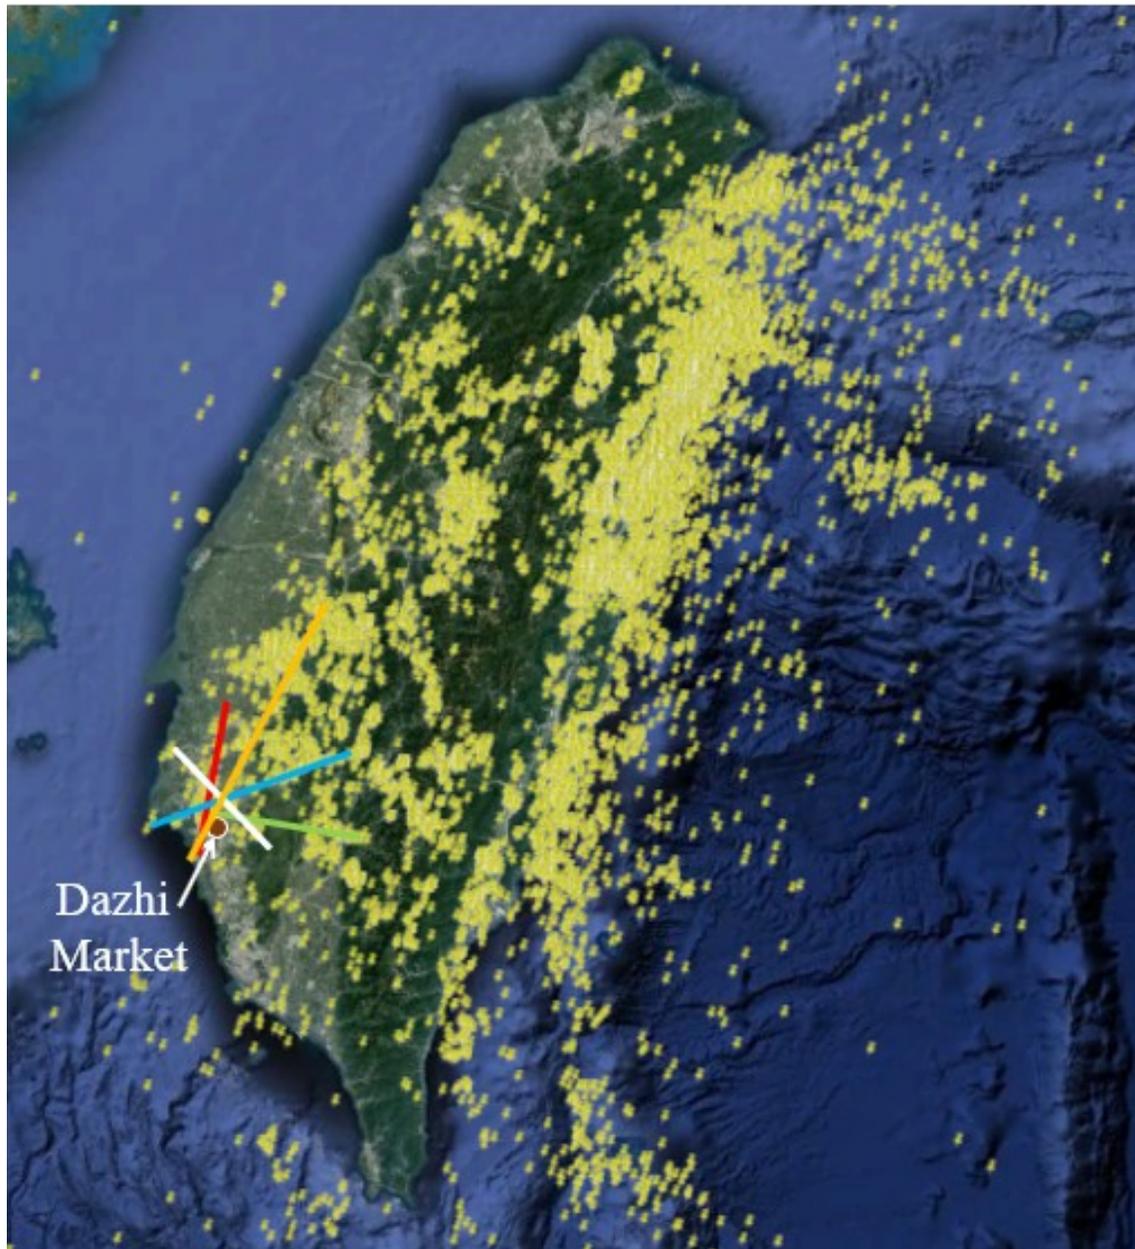
Figure 1. Shear bands identified by the distribution of earthquake epicenters (Google Earth, 2020; GPS LAB, 2007).

By using the linear trends in the distribution of historical epicenters (Hsu and Kang, 2010) in Taiwan, as shown in Figure 1(a), five groups of shear bands shown in Figure 1(b) were identified, with strikes of N11°E (red), N28°E (orange), N70°E (blue), N45°W (white), and N80°W (green).

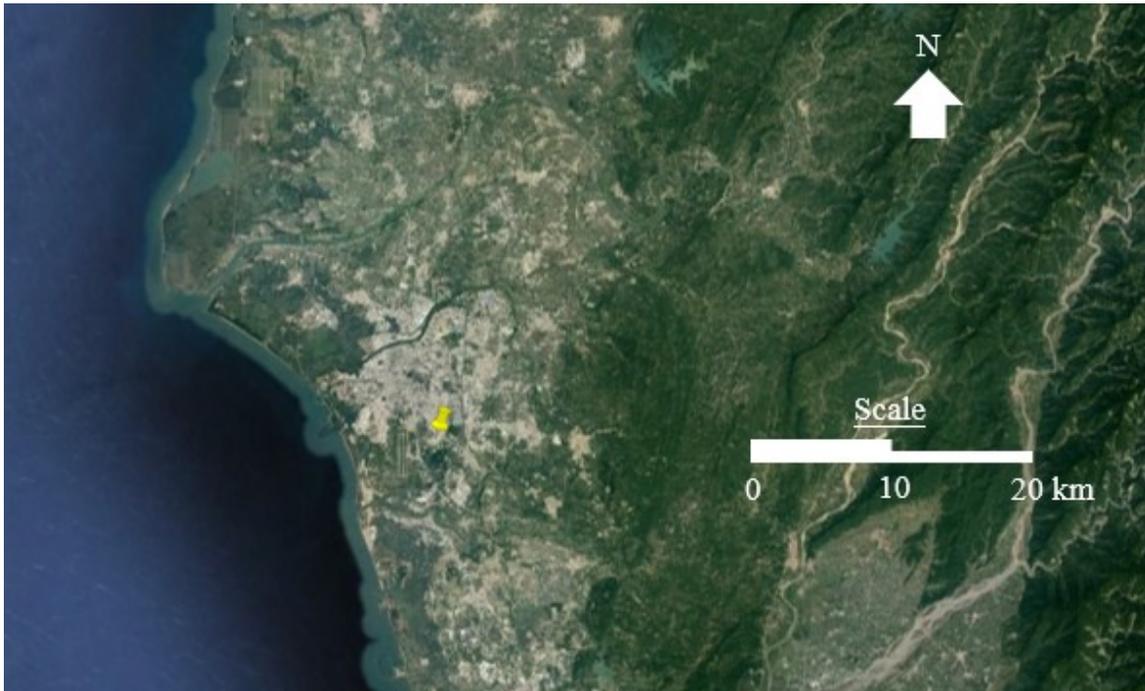
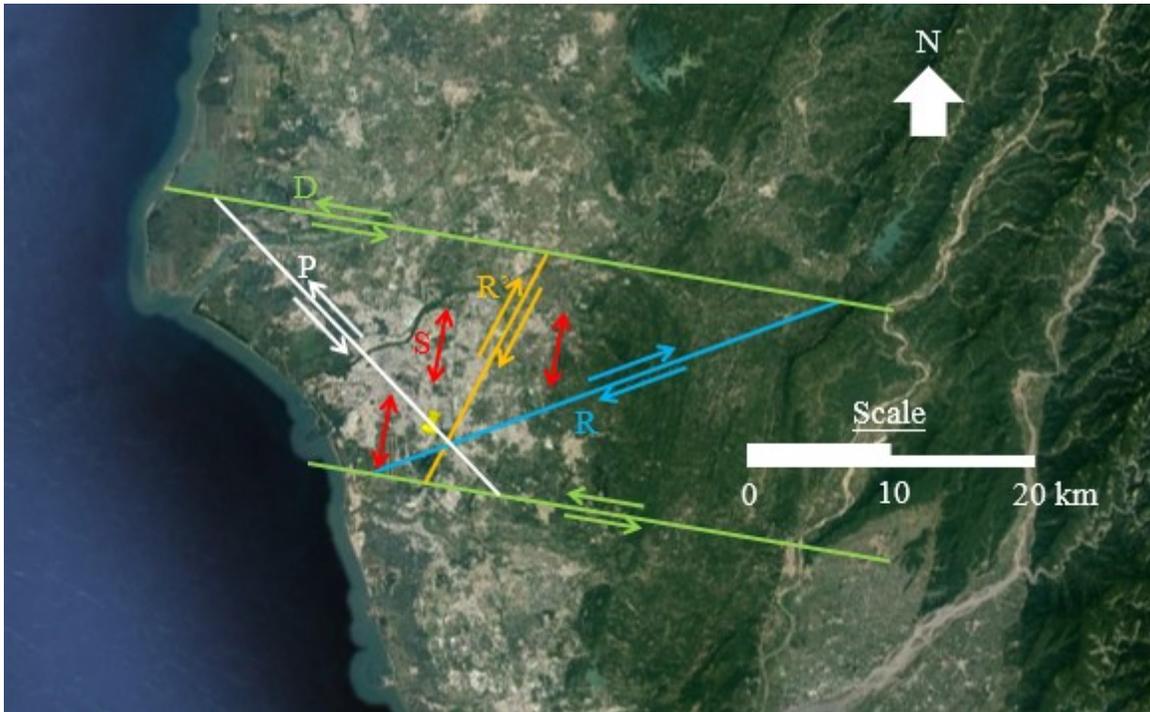
Figure 2. Shear band and shear textures identified by satellite imagery (Google Earth, 2020).

Using the satellite image (Hsu and Kang, 2010) of the adjacent area of the Dazhi Market building shown in Figure 2(a), shear-band landform features, and the definitions of shear textures, five groups of shear textures were identified in the overall shear band width, as shown in Figure 2(b), with

strikes of  $N11^{\circ}E$  (compression texture in red),  $N28^{\circ}E$  (conjugate Riedel shear in orange),  $N70^{\circ}E$  (Riedel shear in blue),  $N45^{\circ}W$  (thrust shear in white), and  $N80^{\circ}W$  (principal deformation shear in green).

Note: The yellow needle point indicates the Dazhi Market building.

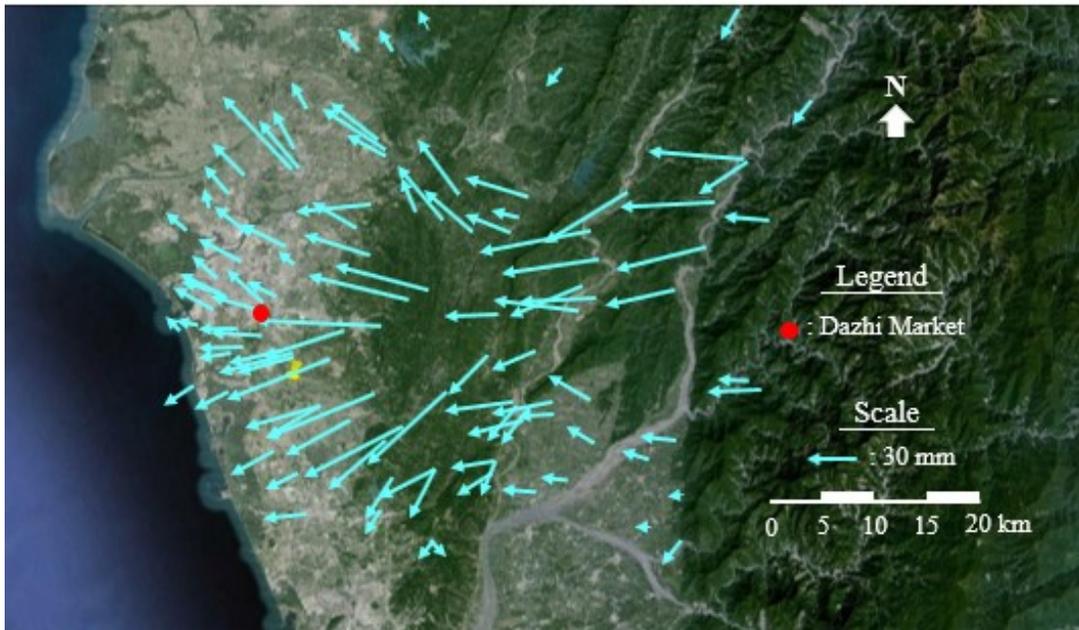
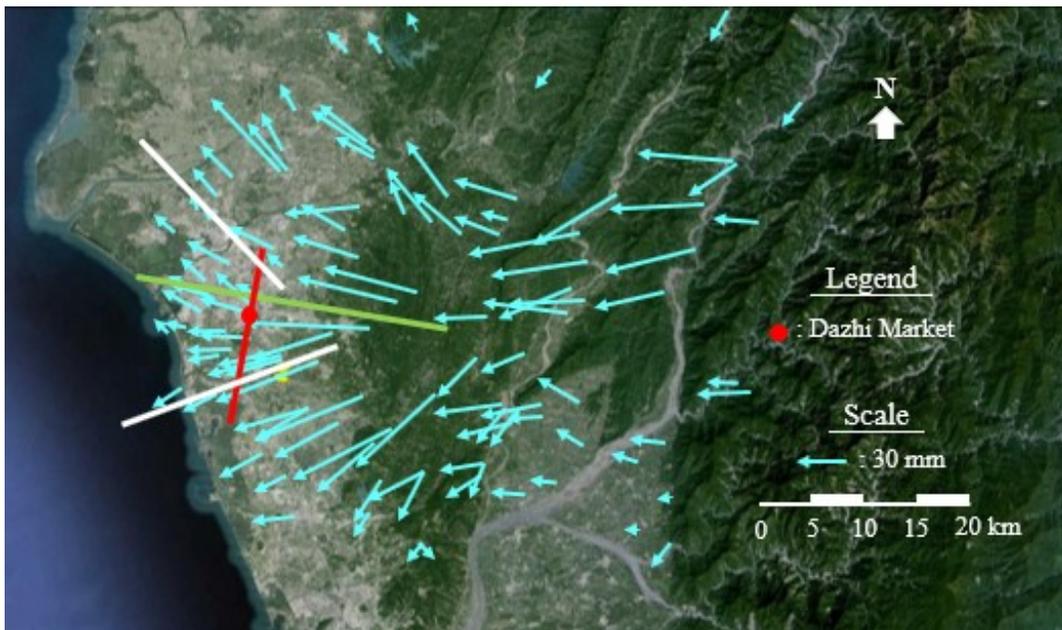
Figure 3. Shear bands identified by GPS velocity vectors (Google Earth, 2020; Central Geological Survey, MOEA, 2016).

Using the GPS velocity vector distribution map shown Figure 3(a) in conjunction with the definition of shear bands in the vicinity of the site, four groups of shear bands shown in Figure

3(b) were identified in the vicinity of the site; the corresponding strikes are N11°E (red), N70°E (blue), N45°W (white), and N80°W (green).
