THE MAJOR CAUSE OF BUILDING FALL FAILURES DURING TECTONIC EARTHQUAKES

Tse-Shan Hsu
Department of Civil Engineering, Feng-Chia University
Taiwan R.O.C.
tshsu@fcu.edu.tw

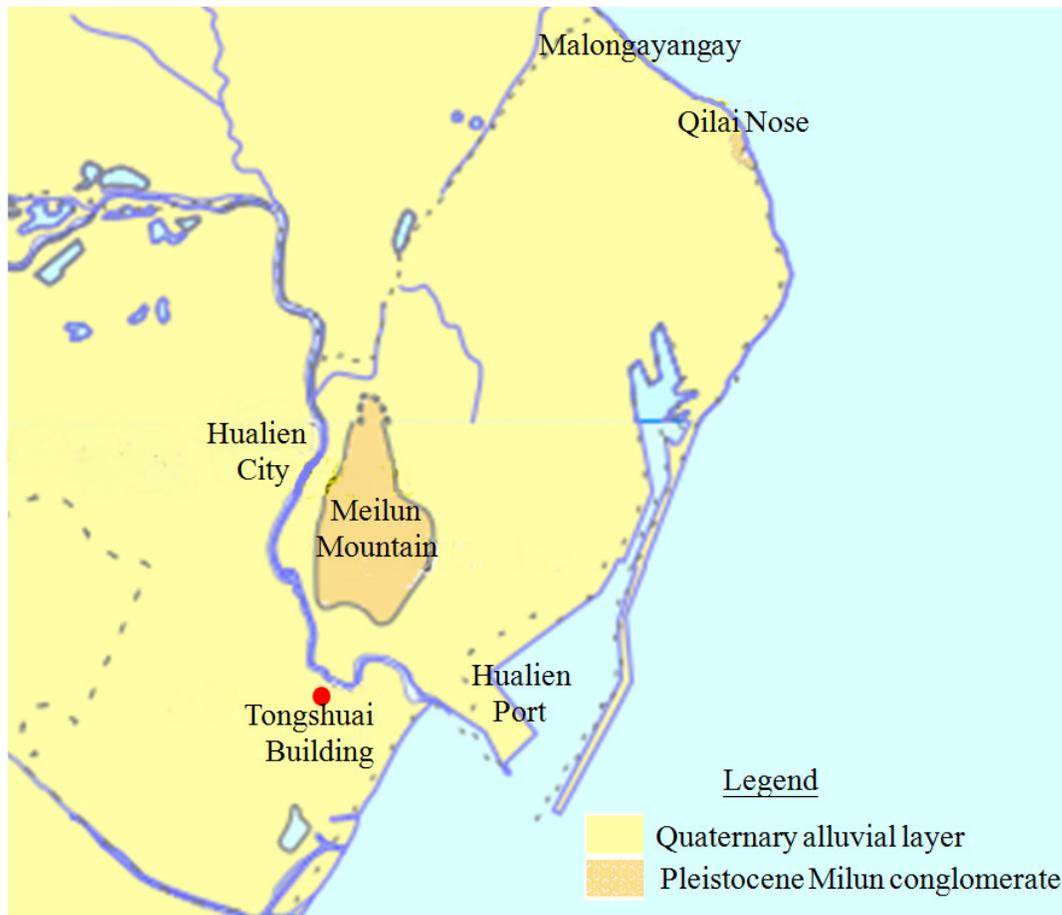
Figure 7. The geological map for the area surrounding the Tongshuai Building (Central Geological Survey of Taiwan, System of Geology in Taiwan, 2018)

Figure 7 shows the geological map for the area near the Tongshuai Building. From Figure 7, the Tongshuai Building is located on a quater-

nary alluvial layer, which is mainly composed of silty sand, but the geology of Meilun Mountain is Pleistocene Milun conglomerate.

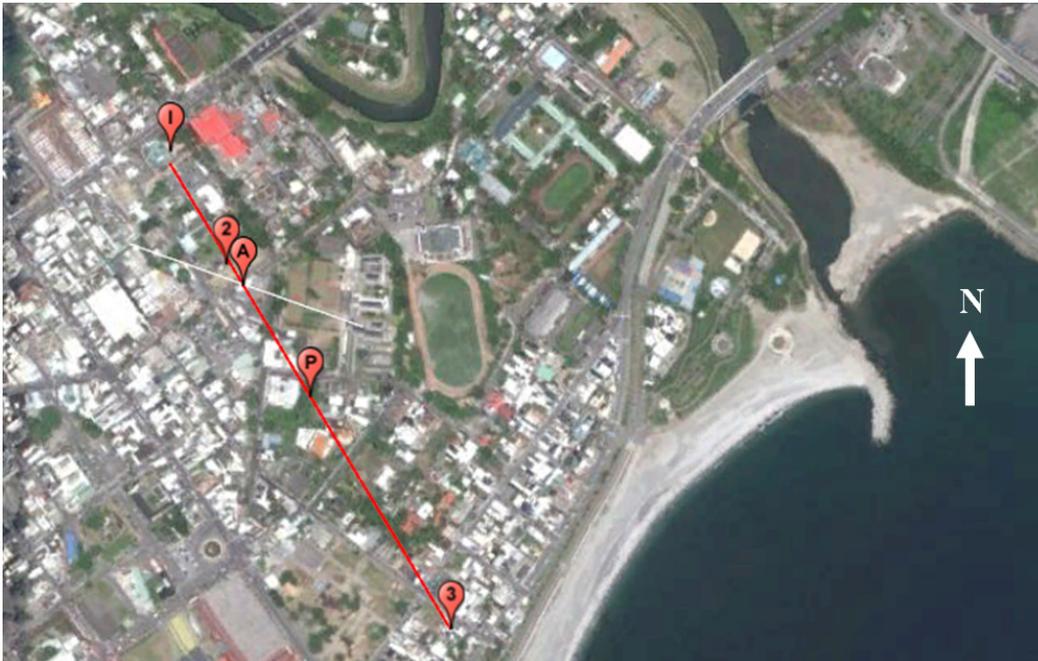
(a) Measuring line passing five points 1, 2, A, P, 3 (Google Earth, 2018)

Since a shear band of thrust type can uplift hanging wall of the land, according to the shear band of thrust type shown in Figure 12 and Figure 13, it can be inferred that the Tongshuai

Building is located on a tilted slope, in which the eastern side is higher than the western side. This inference can be confirmed by the elevation profile shown in Figure 14b.

Remark: A is the location of the Tongshuai Building; 2 is location of Milun Fault.

Figure 14b indicates that the Tongshuai Building is located on the shear textures of a shear band related to the Milun Fault, and the 0206 Hualien Earthquake has been confirmed to be induced by Milun Faulting according to the geological investigation of the Department of the Economy; however, because the magnitude of the earthquake was only 6.0, the cumulated amount of shear banding in the urban area of Hualien city is not so significant. Therefore, the Tongshuai Building fall failure was triggered by combined conditions. These conditions include: (1) $FE_s = 3.0$; (2) the GWT is above the bottom surface of the foundation; (3) the foundation soil contains shear textures of a shear band; (4) ϕ_r for foundation soils is 30° ; (5) k_h and k_v are 0.153 and 0.0765, respectively. Under such conditions, the calculated FS_E is less than 1.0, and when seismic settlement occurred and sud-

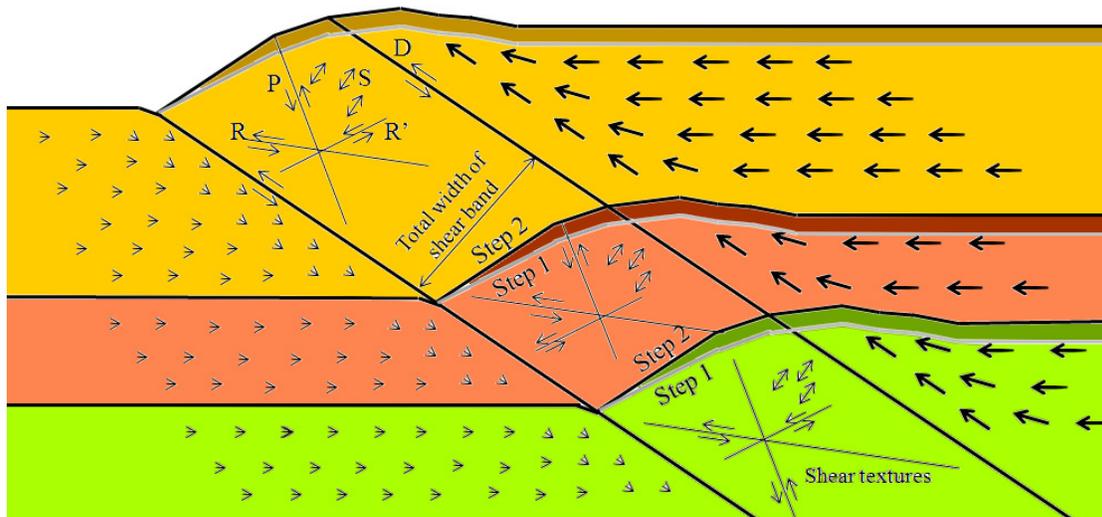
Figure 16. A schematic diagram for the shear band tilting slope

Under the lateral compression of the tectonic plate, Figure 16 shows a shear band tilting slope. It is to be stressed that after each tectonic earthquake, shear banding effect is cumulated continuously while the ground

vibration effect is zeroed. Thus when tectonic earthquakes happen continuously, the degree of fracture for the shear band soils becomes more and more significant.

The effect of shear banding can not only reduce the cohesion of the soils or rocks to zero, but can also transfer the angle of internal friction from the peak value to the residual one. In addition, the elevation of the hanging wall relative to the foot wall induced by shear banding can also lead to local uplift in a construction site, which has been leveled by digging and filling previously.
